Access Compliance Report

Public Rights-of-Way

(Curb Ramps)

Intersection ID: 10011809	Main Street: STATESVILLE_RD	Cross Street: N/A	Location: SE
ADA ID: 33FECB296451	Ramp Type: PerpDiag	Initial Pass/Fail: Fail	Overall Compliance: No
Severity Score: 8.75			
Codes/Mitigation Info/Possible Solution		Field Measurements/Component Compliance

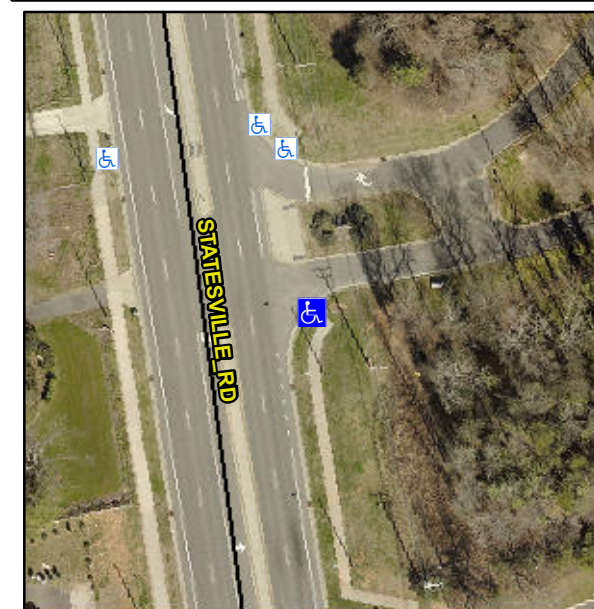
Not Found, R304.5.1

Compliance	Description	Data	Compliance	Description	Data
N/A	Ramp Length (in)	103.0	Yes	Ramp Slope (%)	7.1
No	Ramp Width (in)	47.0	Yes	Ramp XSlope (%)	0.8
N/A	Flare Type LT	N/A	N/A	Flare Type RT	N/A
N/A	Flare Slope LT (%)	N/A	N/A	Flare Slope RT (%)	N/A
N/A	Flare Traversable LT?	N/A	N/A	Flare Traversable RT?	N/A
N/A	Landing Length (in)	N/A	N/A	DWS Provided?	N/A
N/A	Landing Width (in)	N/A	N/A	DWS Contrast?	N/A
N/A	Landing Slope (%)	N/A	N/A	DWS Length (in)	N/A
N/A	Landing X Slope (%)	N/A	N/A	DWS Full Width?	N/A
N/A	Landing Curb? (Y/N)	N/A	N/A	DWS Offset (in)	N/A
N/A	Shared Landing?	N/A			
N/A	Gutter Ponding?	N/A	N/A	Gutter Slope (%)	N/A
N/A	Gutter Lip Ht (in)	N/A	N/A	Gutter X Slope (%)	N/A
N/A	Painted X Walk1?	No	N/A	Painted X Walk2?	No
	X Walk 1 Direction	To N		X Walk 2 Direction	To W
N/A	X Walk 1 Width (in)	N/A	N/A	X Walk 2 Width (in)	N/A
	X Walk 1 Slope (%)	0.6		X Walk 2 Slope (%)	0.1
	X Walk 1 X Slope (%)	0.7		X Walk 2 X Slope (%)	0.1

N/A	Ramp inside XWalk1?	N/A	N/A	Ramp inside XWalk2?	N/A
	Road Slope (%)	0.5	N/A	Clear Space?	N/A
	Road X Slope (%)	0.4	N/A	Clear Space to XWalk (in)	N/A
N/A	Any Obstructions?	N/A	N/A	Storm Grate/Utility Hazard?	N/A
	Obstruction Type			Storm Grate/Utility Type	
		N/A			N/A
		Yes		Surface Condition? (G/P)	Good

Remove & Replace Curb Ramp With Two New Directional Ramps or Equivalent.
