Access Compliance Report

Public Rights-of-Way

(Curb Ramps)

| Intersection ID: 12109 | Main Street: COUNTRY CLUB DR | Cross Street: DUNLAVIN WY | Location: N |

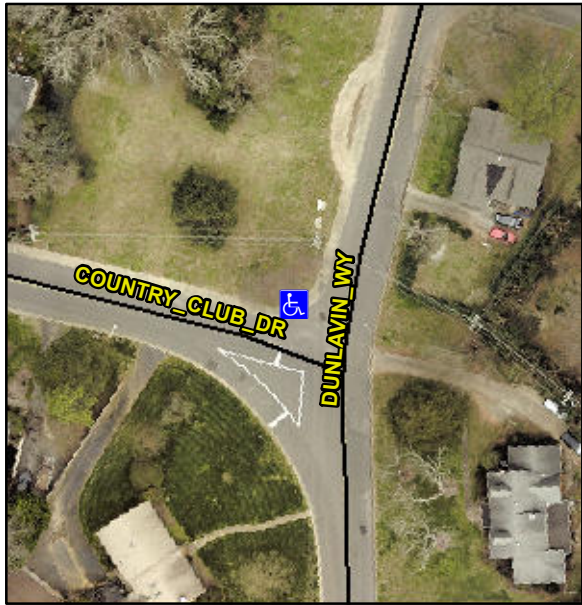
| ADA ID: 340B4397F91B | Ramp Type: PerpDiag | Initial Pass/Fail: Fail | Overall Compliance: No |

| Codes/Mitigation Info/Possible Solution | | | Field Measurements/Component Compliance | | | | | |
|--|--|---|---|---|---|---|---|---|
| | Remove & Replace Curb Ramp With Two New Directional Ramps or Equivalent. | | N/A | Ramp Length (in) | 62.0 | No | Ramp Slope (%) | 13.2 |
| | | | Yes | Ramp Width (in) | 69.0 | No | Ramp XSlope (%) | 2.3 |
| PROW/ADA: | | Not Found, R304.2.2, R304.5.3 | N/A | Shared Landing? | N/A | | | |
| | | | N/A | Gutter Ponding? | Yes | N/A | Gutter Slope (%) | N/A |
