Access Compliance Report

Public Rights-of-Way

(Curb Ramps)

Intersection ID: 20236	Main Street: CAMERON_VALLEY_PY	Cross Street: MORRISON_BV	Location: NW
ADA ID: 341397EAD8CA	Ramp Type: Directional1	Initial Pass/Fail: Fail	Overall Compliance: No
Severity Score: 1.25			
Codes/Mitigation Info/Possible Solution		Field Measurements/Component Compliance

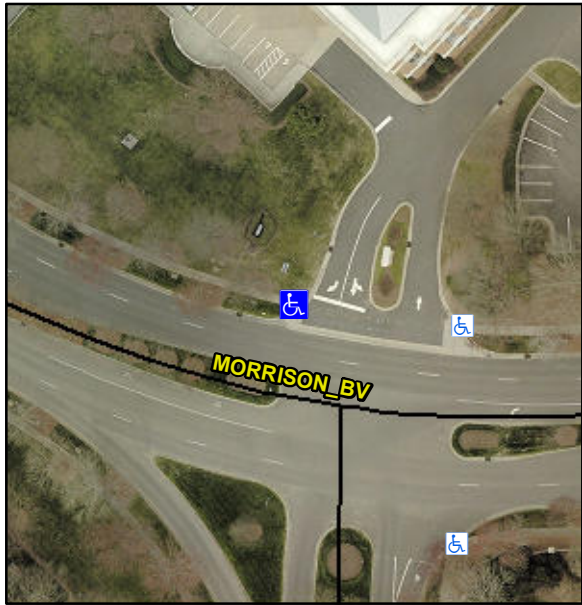
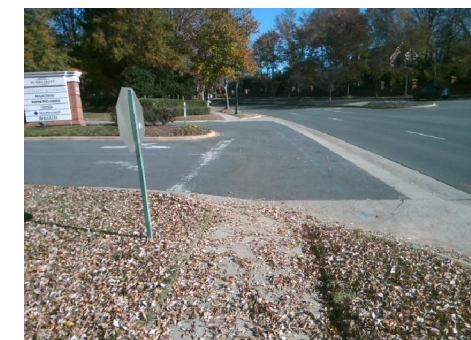
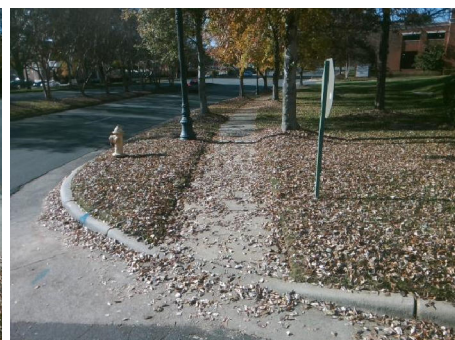
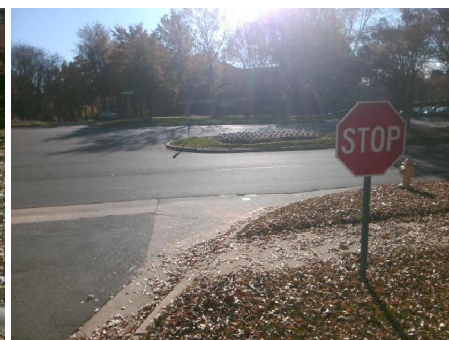
Compliance	Description	Data	Compliance	Description	Data
N/A	Ramp Length (in)	43.0	N/A	Grade Break?	N/A
Yes	Ramp Width (in)	58.0	N/A	Grade Break Slope (%)	0.0
Yes	Ramp Slope (%)	5.1	N/A	Grade Break XSlope (%)	0.0
No	Ramp XSlope (%)	4.8			
N/A	Flare Type LT	N/A	N/A	Flare Type RT	N/A
N/A	Flare Slope LT (%)	N/A	N/A	Flare Slope RT (%)	0.0
N/A	Flare Traversable LT?	N/A	N/A	Flare Traversable RT?	N/A
N/A	Landing Length (in)	0.0	N/A	DWS Provided?	N/A
N/A	Landing Width (in)	0.0	N/A	DWS Contrast?	N/A
N/A	Landing Slope (%)	0.0	N/A	DWS Length (in)	N/A
N/A	Landing X Slope (%)	0.0	N/A	DWS Full Width?	N/A
N/A	Landing Curb? (Y/N)	N/A	N/A	DWS Offset LT (in)	N/A
N/A	Shared Landing?	N/A	N/A	DWS Offset RT (in)	N/A
N/A	Gutter Ponding?	0.0	N/A	Gutter Slope (%)	N/A
N/A	Gutter Lip Ht (in)	0.0	N/A	Gutter X Slope (%)	N/A
N/A	Painted X Walk1?	No		Road Slope (%)	8.7
	X Walk 1 Direction	To E		Road X Slope (%)	0.6
	X Walk 1 Width (in)	N/A		Clear Space?	N/A

X Walk 1 Slope (%)	8.7	N/A	Clear Space to XWalk (in)	N/A
	X Walk 1 X Slope (%)	0.6	N/A	Storm Grate/Utility Hazard?	N/A
N/A	Ramp inside XWalk1?	N/A		Storm Grate/Utility Type	
N/A	Any Obstructions?	N/A			N/A
	Obstruction Type		Yes	Surface Condition? (G/P)	Good
		N/A	N/A	Curb Slope (%)	14.1

Possible Solutions:

Remove & Replace Entire Ramp.

R304.5.3
