Access Compliance Report

Public Rights-of-Way (Curb Ramps)

Intersection ID: 10035065		Main Street: PROVIDENCE_RD		Cross Street: N/A		Location: S											
ADA ID: 341788B216D4		Ramp Type: Directional1		Initial Pass/Fail: Fail		Overall Compliance: No		Severity Score: 25									
Codes/Mitigation Info/Possible Solution				Field Measurements/Component Compliance													
<div>

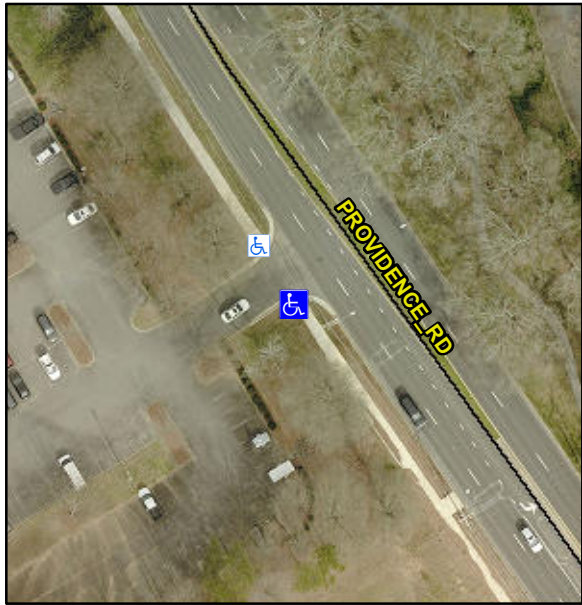
No		Ramp XSlope (%)		11.4									
				N/A		Flare Type LT		N/A		N/A		Flare Type RT		N/A		N/A	
				N/A		Flare Slope LT (%)		N/A		N/A		Flare Slope RT (%)		N/A		0.0	
				N/A		Flare Traversable LT?		N/A		N/A		Flare Traversable RT?		N/A		N/A	
				N/A		Landing Length (in)		0.0		N/A		DWS Provided?		N/A		N/A	
				N/A		Landing Width (in)		0.0		N/A		DWS Contrast?		N/A		N/A	
				N/A		Landing Slope (%)		0.0		N/A		DWS Length (in)		N/A		N/A	
				N/A		Landing X Slope (%)		0.0		N/A		DWS Full Width?		N/A		N/A	
				N/A		Landing Curb? (Y/N)		N/A		N/A		DWS Offset LT (in)		N/A		N/A	
				N/A		Shared Landing?		N/A		N/A		DWS Offset RT (in)		N/A		N/A	
				N/A		Gutter Ponding?		0.0		N/A		Gutter Slope (%)		N/A		N/A	
				N/A		Gutter Lip Ht (in)		0.0		N/A		Gutter X Slope (%)		N/A		N/A	
				N/A		Painted X Walk1?		No				Road Slope (%)				1.1	
						X Walk 1 Direction		To NW				Road X Slope (%)				11.6	
						X Walk 1 Width (in)		N/A				Clear Space?				N/A

</div> <div>Possible Solutions:</div> <div>Remove & Replace Entire Ramp.</div> <div>Surveyor Notes:</div> <div>N/A</div> <div>PROW/ADA:</div> <div>R304.5.3</div> <div>Street 1 NameENTRANCE</div> <div>Stop Condition-Street 1StopSign</div> <div>Street 2 NameN/A</div> <div>Stop Condition-Street 2N/A</div> <div>Total Cost:\$ 1600.00</div>				Compliance		Description		Data		Compliance		Description		Data			
				N/A		Ramp Length (in)		70.0		N/A		Grade Break?		N/A		N/A	
				Yes		Ramp Width (in)		70.0		N/A		Grade Break Slope (%)		N/A		0.0	
				Yes		Ramp Slope (%)		6.4		N/A		Grade Break XSlope (%)		N/A		0.0

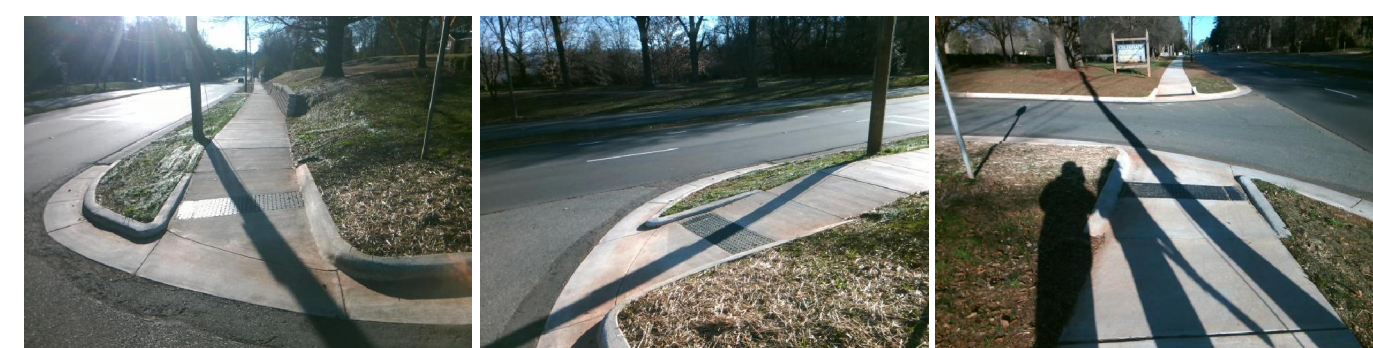
X Walk 1 Slope (%)		1.1		N/A		Clear Space to XWalk (in)		N/A		N/A	
		X Walk 1 X Slope (%)		11.6		N/A		Storm Grate/Utility Hazard?		N/A		N/A					
		Ramp inside XWalk1?		N/A				Storm Grate/Utility Type									
		Any Obstructions?		N/A								N/A					
		Obstruction Type				Yes		Surface Condition? (G/P)		Good							
						N/A		N/A		Curb Slope (%)		1.0
