Access Compliance Report

Public Rights-of-Way

(Curb Ramps)

Intersection ID: 30144	Main Street: CAGNEY_ST	Cross Street: RUMPLE_RD	Location: W
ADA ID: 341EFD2499B7	Ramp Type: Perp	Initial Pass/Fail: Fail	Overall Compliance: No
Severity Score: 8.75			
Codes/Mitigation Info/Possible Solution		Field Measurements/Component Compliance

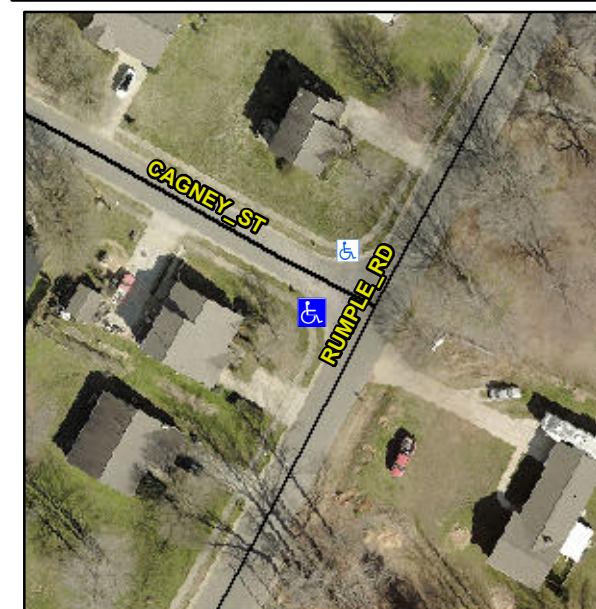
Not Found, R304.5.1

Compliance	Description	Data	Compliance	Description	Data
N/A	Ramp Length (in)	48.0	Yes	Ramp Slope (%)	8.2
No	Ramp Width (in)	41.0	Yes	Ramp XSlope (%)	0.9
N/A	Flare Type LT	N/A	N/A	Flare Type RT	N/A
N/A	Flare Slope LT (%)	N/A	N/A	Flare Slope RT (%)	N/A
N/A	Flare Traversable LT?	N/A	N/A	Flare Traversable RT?	N/A
N/A	Landing Length (in)	N/A	N/A	DWS Provided?	N/A
N/A	Landing Width (in)	N/A	N/A	DWS Contrast?	N/A
N/A	Landing Slope (%)	N/A	N/A	DWS Length (in)	N/A
N/A	Landing X Slope (%)	N/A	N/A	DWS Full Width?	N/A
N/A	Landing Curb? (Y/N)	N/A	N/A	DWS Offset (in)	N/A
N/A	Shared Landing?	N/A			
N/A	Gutter Ponding?	N/A	N/A	Gutter Slope (%)	N/A
N/A	Gutter Lip Ht (in)	N/A	N/A	Gutter X Slope (%)	N/A
N/A	Painted X Walk1?	No	N/A	Painted X Walk2?	N/A
	X Walk 1 Direction	To NE		X Walk 2 Direction	N/A
N/A	X Walk 1 Width (in)	N/A	N/A	X Walk 2 Width (in)	N/A
	X Walk 1 Slope (%)	1.5		X Walk 2 Slope (%)	N/A
	X Walk 1 X Slope (%)	0.7		X Walk 2 X Slope (%)	N/A

N/A	Ramp inside XWalk1?	N/A	N/A	Ramp inside XWalk2?	N/A
	Road Slope (%)	N/A	N/A	Clear Space?	N/A
	Road X Slope (%)	N/A	N/A	Clear Space to XWalk (in)	N/A
N/A	Any Obstructions?	N/A	N/A	Storm Grate/Utility Hazard?	N/A
	Obstruction Type			Storm Grate/Utility Type	
		N/A			N/A
			Yes	Surface Condition? (G/P)	Good

Possible Solutions:

Remove & Replace Entire Ramp.

Total Cost: \$ 1850.00
