## **Access Compliance Report Public Rights-of-Way** (Curb Ramps)

Intersection ID: 12158 Main Street: W\_MOREHEAD\_ST Cross Street: SUTTLE\_AV Location: SW **Overall Compliance: No** ADA ID: 342B691085FB Ramp Type: Para Initial Pass/Fail: Fail Severity Score: 13.75

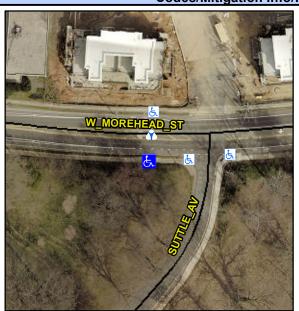
Field Measurements/Component Compliance								
Compl	iance Description	Data	Comp	iance Description	Data			
N/A	Ramp Length LT (in)	67.0	N/A	Ramp Length RT (in)	72.5			
Yes	Ramp Width LT (in)	59.5	Yes	Ramp Width RT (in)	58.0			
Yes	Ramp Slope LT (%)	7.4	No	Ramp Slope RT (%)	9.7			
No	Ramp XSlope LT (%)	2.7	Yes	Ramp XSlope RT (%)	0.7			
N/A	Landing Length (in)	N/A	N/A	DWS Provided?	N/A			
N/A	Landing Width (in)	N/A	N/A	DWS Contrast?	N/A			
N/A	Landing Slope (%)	N/A	N/A	DWS Length (in)	N/A			
N/A	Landing X Slope (%)	N/A	N/A	DWS Full Width?	N/A			
N/A	Landing Curb? (Y/N)	N/A	N/A	DWS Offset (in)	N/A			
N/A	Shared Landing?	N/A						
N/A	Gutter Ponding?	N/A	N/A	Gutter Slope (%)	N/A			
N/A	Gutter Lip Ht (in)	N/A	N/A	Gutter X Slope (%)	N/A			
N/A	Painted X Walk1?	No	N/A	Painted X Walk2?	N/A			
	X Walk 1 Direction	To N		X Walk 2 Direction	N/A			
N/A	X Walk 1 Width (in)	N/A	N/A	X Walk 2 Width (in)	N/A			
	X Walk 1 Slope (%)	5.5		X Walk 2 Slope (%)	N/A

X Walk 1 X Slope (%)	1.7		X Walk 2 X Slope (%)	N/A			
N/A	Ramp inside XWalk1?	N/A	N/A	Ramp inside XWalk2?	N/A			
	Road Slope (%)	N/A	N/A	Clear Space?	N/A			
	Road X Slope (%)	N/A	N/A	Clear Space to XWalk (in)	N/A			
N/A	Any Obstructions?	N/A	N/A	Storm Grate/Utility Hazard?	N/A			
	Obstruction Type			Storm Grate/Utility Type				
		N/A			N/A			
			Yes	Surface Condition? (G/P)	Good			
			N/A	Curb Slope (%)	1.9

Ossible Solution	
Possible Solutions:	<u>c</u>
Remove & Replace Entire Ramp.	N.
·	Ye
	Ye
	N
	N
	N
Surveyor Notes:	N
N/A	N
	N
	N
	N
PROW/ADA:	N/
R304.5.3, R304.3.2	N
	N

Total Cost:	\$ 1600.00
