Access Compliance Report

Public Rights-of-Way

(Curb Ramps)

Intersection ID: 18797	Main Street: SENECA_PL	Cross Street: WEDGEWOOD_DR	Location: SE
ADA ID: 3436FFDC6243	Ramp Type: Perp	Initial Pass/Fail: Fail	Overall Compliance: No
Severity Score: 12.5			
Codes/Mitigation Info/Possible Solution		Field Measurements/Component Compliance

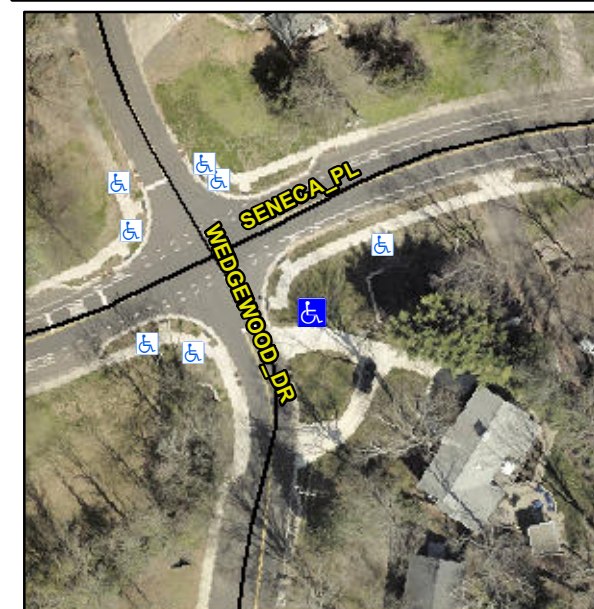
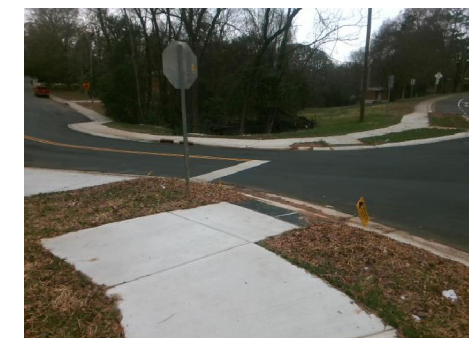
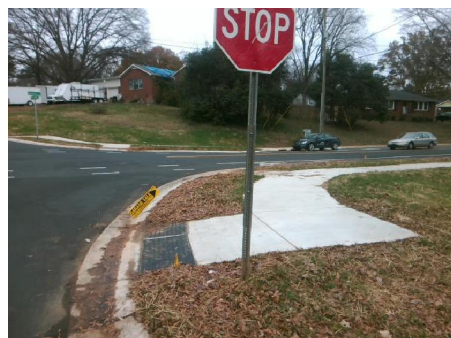
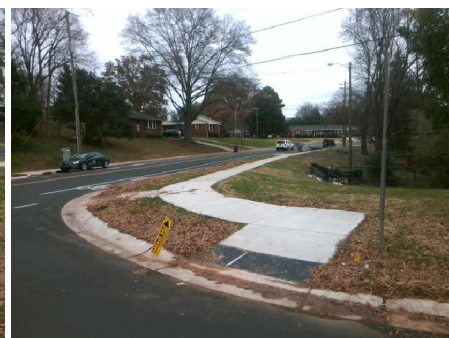
Not Found, R304.2.2

Compliance	Description	Data	Compliance	Description	Data
N/A	Ramp Length (in)	70.0	No	Ramp Slope (%)	8.4
Yes	Ramp Width (in)	72.0	Yes	Ramp XSlope (%)	1.3
N/A	Flare Type LT	N/A	N/A	Flare Type RT	N/A
N/A	Flare Slope LT (%)	N/A	N/A	Flare Slope RT (%)	N/A
N/A	Flare Traversable LT?	N/A	N/A	Flare Traversable RT?	N/A
N/A	Landing Length (in)	N/A	N/A	DWS Provided?	N/A
N/A	Landing Width (in)	N/A	N/A	DWS Contrast?	N/A
N/A	Landing Slope (%)	N/A	N/A	DWS Length (in)	N/A
N/A	Landing X Slope (%)	N/A	N/A	DWS Full Width?	N/A
N/A	Landing Curb? (Y/N)	N/A	N/A	DWS Offset (in)	N/A
N/A	Shared Landing?	N/A			
N/A	Gutter Ponding?	N/A	N/A	Gutter Slope (%)	N/A
N/A	Gutter Lip Ht (in)	N/A	N/A	Gutter X Slope (%)	N/A
N/A	Painted X Walk1?	No	N/A	Painted X Walk2?	N/A
	X Walk 1 Direction	To W		X Walk 2 Direction	N/A
N/A	X Walk 1 Width (in)	N/A	N/A	X Walk 2 Width (in)	N/A
	X Walk 1 Slope (%)	1.2		X Walk 2 Slope (%)	N/A
	X Walk 1 X Slope (%)	1.9		X Walk 2 X Slope (%)	N/A

N/A	Ramp inside XWalk1?	N/A	N/A	Ramp inside XWalk2?	N/A
	Road Slope (%)	N/A	N/A	Clear Space?	N/A
	Road X Slope (%)	N/A	N/A	Clear Space to XWalk (in)	N/A
N/A	Any Obstructions?	N/A	N/A	Storm Grate/Utility Hazard?	N/A
	Obstruction Type			Storm Grate/Utility Type	
		N/A			N/A
			Yes	Surface Condition? (G/P)	Good

Remove & Replace Entire Ramp.
