# Access Compliance Report

## Public Rights-of-Way

### (Curb Ramps)

Intersection ID: 8566	Main Street: HILDEBRAND_ST	Cross Street: TAYLOR_AV	Location: W
ADA ID: 343820E7CCC8	Ramp Type: Perp	Initial Pass/Fail: Fail	Overall Compliance: No
Severity Score: 41.25			
Codes/Mitigation Info/Possible Solution		Field Measurements/Component Compliance

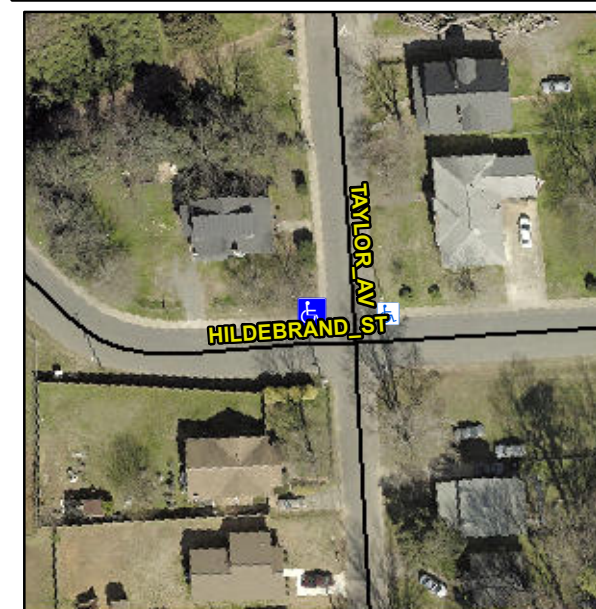
**R304.2.2, R304.5.3, R302.7**

Compliance	Description	Data	Compliance	Description	Data
N/A	Ramp Length (in)	36.0	No	Ramp Slope (%)	14.8
Yes	Ramp Width (in)	56.0	No	Ramp XSlope (%)	3.9
N/A	Flare Type LT	N/A	N/A	Flare Type RT	N/A
N/A	Flare Slope LT (%)	N/A	N/A	Flare Slope RT (%)	N/A
N/A	Flare Traversable LT?	N/A	N/A	Flare Traversable RT?	N/A
N/A	Landing Length (in)	N/A	N/A	DWS Provided?	N/A
N/A	Landing Width (in)	N/A	N/A	DWS Contrast?	N/A
N/A	Landing Slope (%)	N/A	N/A	DWS Length (in)	N/A
N/A	Landing X Slope (%)	N/A	N/A	DWS Full Width?	N/A
N/A	Landing Curb? (Y/N)	N/A	N/A	DWS Offset (in)	N/A
N/A	Shared Landing?	N/A			
N/A	Gutter Ponding?	N/A	N/A	Gutter Slope (%)	N/A
N/A	Gutter Lip Ht (in)	N/A	N/A	Gutter X Slope (%)	N/A
N/A	Painted X Walk1?	No	N/A	Painted X Walk2?	N/A
	X Walk 1 Direction	To E		X Walk 2 Direction	N/A
N/A	X Walk 1 Width (in)	N/A	N/A	X Walk 2 Width (in)	N/A
	X Walk 1 Slope (%)	3.9		X Walk 2 Slope (%)	N/A
	X Walk 1 X Slope (%)	0.8		X Walk 2 X Slope (%)	N/A

N/A	Ramp inside XWalk1?	N/A	N/A	Ramp inside XWalk2?	N/A
	Road Slope (%)	N/A	N/A	Clear Space?	N/A
	Road X Slope (%)	N/A	N/A	Clear Space to XWalk (in)	N/A
N/A	Any Obstructions?	N/A	N/A	Storm Grate/Utility Hazard?	N/A
	Obstruction Type			Storm Grate/Utility Type	
		N/A			N/A
		No		Surface Condition? (G/P)	Poor

**Remove & Replace Entire Ramp.**

Total Cost: \$ 1850.00
