# Access Compliance Report

## Public Rights-of-Way

### (Curb Ramps)

| Intersection ID: 21297 | Main Street: STARBROOK_DR | Cross Street: WRENTREE_DR | Location: S |

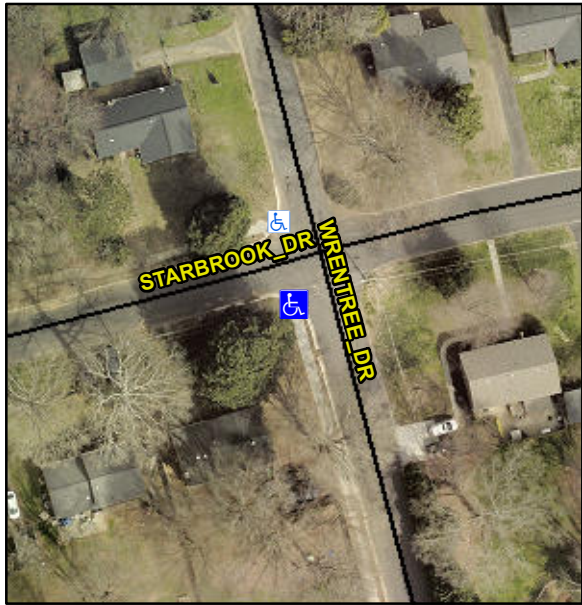
| ADA ID: 34393C56F5D7 | Ramp Type: Directional1 | Initial Pass/Fail: Fail | Overall Compliance: No |
| | | Severity Score: 12.5 | |

| Codes/Mitigation Info/Possible Solution | | | Field Measurements/Component Compliance | | | | | | | |
|---|---|---|---|---|---|---|---|---|---|--|
| | | | <b>No</b> | Ramp Slope (%) | <b>8.7</b> | <b>N/A</b> | Grade Break XSlope (%) | <b>0.0</b> | | |
| | | | | | <b>N/A</b> | Curb Slope (%) | <b>13.8</b> | | | |

| Codes/Mitigation Info/Possible Solution | | | Field Measurements/Component Compliance | | | | | | | |
|---|---|---|---|---|---|---|---|---|---|--|
| | <b>Remove &amp; Replace Entire Ramp.</b> | | <b>N/A</b> | Ramp Length (in) | <b>40.0</b> | <b>N/A</b> | Grade Break? | <b>N/A</b> | | |
| <b>R304.2.2</b> | | | | | | | | | | |
| Total Cost: | | <b>\$</b> | <b>1600.00</b> | | | | | | | |
