Access Compliance Report

Public Rights-of-Way

(Curb Ramps)

Intersection ID: 10032791	Main Street: N_WENDOVER_RD	Cross Street: N/A	Location: SW
ADA ID: 343ACC68ECA8	Ramp Type: PerpDiag	Initial Pass/Fail: Fail	Overall Compliance: No
		Severity Score: 12.5

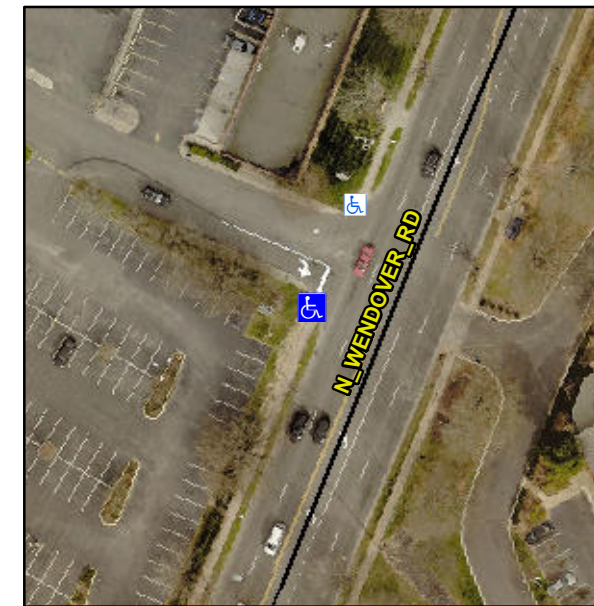
Not Found, R304.2.2

Compliance	Description	Data	Compliance	Description	Data
N/A	Ramp Length (in)	68.0	No	Ramp Slope (%)	8.6
Yes	Ramp Width (in)	48.0	Yes	Ramp XSlope (%)	0.2
N/A	Flare Type LT	N/A	N/A	Flare Type RT	N/A
N/A	Flare Slope LT (%)	N/A	N/A	Flare Slope RT (%)	N/A
N/A	Flare Traversable LT?	N/A	N/A	Flare Traversable RT?	N/A
N/A	Landing Length (in)	N/A	N/A	DWS Provided?	N/A
N/A	Landing Width (in)	N/A	N/A	DWS Contrast?	N/A
N/A	Landing Slope (%)	N/A	N/A	DWS Length (in)	N/A
N/A	Landing X Slope (%)	N/A	N/A	DWS Full Width?	N/A
N/A	Landing Curb? (Y/N)	N/A	N/A	DWS Offset (in)	N/A
N/A	Shared Landing?	N/A			
N/A	Gutter Ponding?	N/A	N/A	Gutter Slope (%)	N/A
N/A	Gutter Lip Ht (in)	N/A	N/A	Gutter X Slope (%)	N/A
N/A	Painted X Walk1?	No	N/A	Painted X Walk2?	No
	X Walk 1 Direction	To NE		X Walk 2 Direction	To NW
N/A	X Walk 1 Width (in)	N/A	N/A	X Walk 2 Width (in)	N/A
	X Walk 1 Slope (%)	5.3		X Walk 2 Slope (%)	0.4
	X Walk 1 X Slope (%)	1.2		X Walk 2 X Slope (%)	3.8

N/A	Ramp inside XWalk1?	N/A	N/A	Ramp inside XWalk2?	N/A
	Road Slope (%)	1.5	N/A	Clear Space?	N/A
	Road X Slope (%)	4.6	N/A	Clear Space to XWalk (in)	N/A
N/A	Any Obstructions?	N/A	N/A	Storm Grate/Utility Hazard?	N/A
	Obstruction Type			Storm Grate/Utility Type	
		N/A			N/A
			Yes	Surface Condition? (G/P)	Good

Remove & Replace Curb Ramp With Two New Directional Ramps or Equivalent.

Total Cost: \$ 3200.00
