Access Compliance Report

Public Rights-of-Way

(Curb Ramps)

Intersection ID: 50242	Main Street: BLAIREBETH_ST	Cross Street: CEDAR_WALK_LN	Location: SE
ADA ID: 3448742A6967	Ramp Type: PerpDiag	Initial Pass/Fail: Fail	Overall Compliance: No
Severity Score: 8.75			
Codes/Mitigation Info/Possible Solution		Field Measurements/Component Compliance

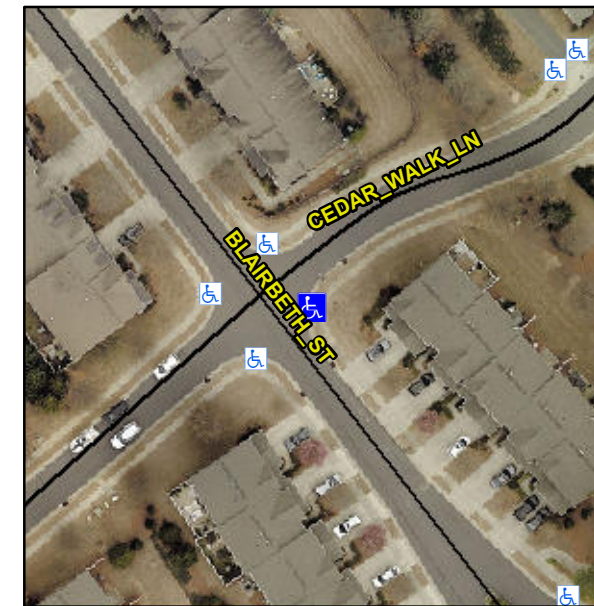
Not Found, R304.5.1

Compliance	Description	Data	Compliance	Description	Data
N/A	Ramp Length (in)	46.0	Yes	Ramp Slope (%)	8.2
No	Ramp Width (in)	47.0	Yes	Ramp XSlope (%)	1.7
N/A	Flare Type LT	N/A	N/A	Flare Type RT	N/A
N/A	Flare Slope LT (%)	N/A	N/A	Flare Slope RT (%)	N/A
N/A	Flare Traversable LT?	N/A	N/A	Flare Traversable RT?	N/A
N/A	Landing Length (in)	N/A	N/A	DWS Provided?	N/A
N/A	Landing Width (in)	N/A	N/A	DWS Contrast?	N/A
N/A	Landing Slope (%)	N/A	N/A	DWS Length (in)	N/A
N/A	Landing X Slope (%)	N/A	N/A	DWS Full Width?	N/A
N/A	Landing Curb? (Y/N)	N/A	N/A	DWS Offset (in)	N/A
N/A	Shared Landing?	N/A			
N/A	Gutter Ponding?	N/A	N/A	Gutter Slope (%)	N/A
N/A	Gutter Lip Ht (in)	N/A	N/A	Gutter X Slope (%)	N/A
N/A	Painted X Walk1?	No	N/A	Painted X Walk2?	No
	X Walk 1 Direction	To NW		X Walk 2 Direction	To SW
N/A	X Walk 1 Width (in)	N/A	N/A	X Walk 2 Width (in)	N/A
	X Walk 1 Slope (%)	2.5		X Walk 2 Slope (%)	0.2
	X Walk 1 X Slope (%)	0.1		X Walk 2 X Slope (%)	2.2

N/A	Ramp inside XWalk1?	N/A	N/A	Ramp inside XWalk2?	N/A
	Road Slope (%)	1.2	N/A	Clear Space?	N/A
	Road X Slope (%)	0.2	N/A	Clear Space to XWalk (in)	N/A
N/A	Any Obstructions?	N/A	N/A	Storm Grate/Utility Hazard?	N/A
	Obstruction Type			Storm Grate/Utility Type	
		N/A			N/A
			Yes	Surface Condition? (G/P)	Good

Possible Solutions:

Remove & Replace Curb Ramp With Two New Directional Ramps or Equivalent.

Total Cost: \$ 3200.00
