Access Compliance Report

Public Rights-of-Way

(Curb Ramps)

Intersection ID: 14600	Main Street: DILWORTH_RD	Cross Street: DILWORTH_RD_EAST	Location: NW
ADA ID: 344F871E6332	Ramp Type: Perp	Initial Pass/Fail: Fail	Overall Compliance: No
Severity Score: 13.75			
Codes/Mitigation Info/Possible Solution		Field Measurements/Component Compliance

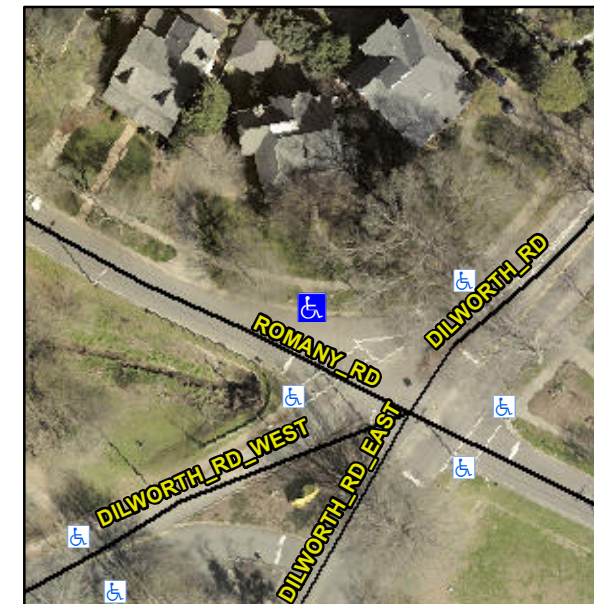
Not Found, R304.2.2, R304.5.3

Compliance	Description	Data	Compliance	Description	Data
N/A	Ramp Length (in)	57.0	No	Ramp Slope (%)	9.5
Yes	Ramp Width (in)	48.0	No	Ramp XSlope (%)	3.5
N/A	Flare Type LT	N/A	N/A	Flare Type RT	N/A
N/A	Flare Slope LT (%)	N/A	N/A	Flare Slope RT (%)	N/A
N/A	Flare Traversable LT?	N/A	N/A	Flare Traversable RT?	N/A
N/A	Landing Length (in)	N/A	N/A	DWS Provided?	N/A
N/A	Landing Width (in)	N/A	N/A	DWS Contrast?	N/A
N/A	Landing Slope (%)	N/A	N/A	DWS Length (in)	N/A
N/A	Landing X Slope (%)	N/A	N/A	DWS Full Width?	N/A
N/A	Landing Curb? (Y/N)	N/A	N/A	DWS Offset (in)	N/A
N/A	Shared Landing?	N/A			
N/A	Gutter Ponding?	N/A	N/A	Gutter Slope (%)	N/A
N/A	Gutter Lip Ht (in)	N/A	N/A	Gutter X Slope (%)	N/A
N/A	Painted X Walk1?	No	N/A	Painted X Walk2?	N/A
	X Walk 1 Direction	To SW		X Walk 2 Direction	N/A
N/A	X Walk 1 Width (in)	N/A	N/A	X Walk 2 Width (in)	N/A
	X Walk 1 Slope (%)	1.4		X Walk 2 Slope (%)	N/A
	X Walk 1 X Slope (%)	1.9		X Walk 2 X Slope (%)	N/A

N/A	Ramp inside XWalk1?	N/A	N/A	Ramp inside XWalk2?	N/A
	Road Slope (%)	N/A	N/A	Clear Space?	N/A
	Road X Slope (%)	N/A	N/A	Clear Space to XWalk (in)	N/A
N/A	Any Obstructions?	N/A	N/A	Storm Grate/Utility Hazard?	N/A
	Obstruction Type			Storm Grate/Utility Type	
		N/A			N/A
			Yes	Surface Condition? (G/P)	Good

Possible Solutions:

Remove & Replace Entire Ramp.
