Access Compliance Report

Public Rights-of-Way

(Curb Ramps)

Intersection ID: 6149	Main Street: STATESVILLE_RD	Cross Street: SUNTRACE_RD	Location: SW
ADA ID: 345675720B97	Ramp Type: Perp	Initial Pass/Fail: Fail	Overall Compliance: No
Severity Score: 8.75			
Codes/Mitigation Info/Possible Solution		Field Measurements/Component Compliance

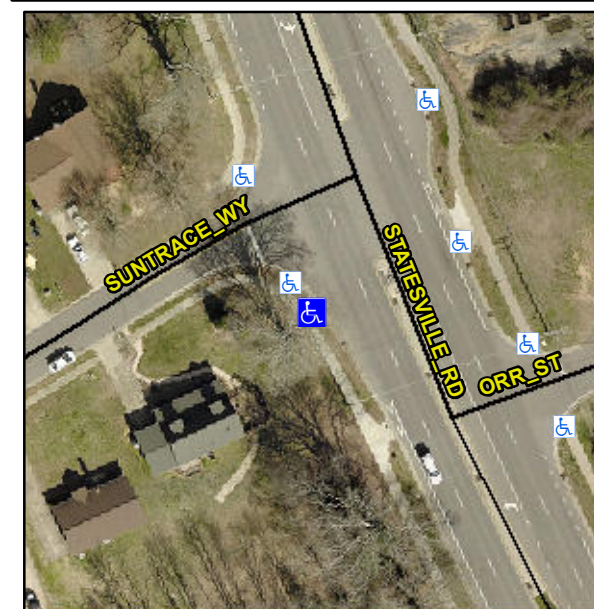
R304.5.1

Compliance	Description	Data	Compliance	Description	Data
N/A	Ramp Length (in)	73.0	Yes	Ramp Slope (%)	7.6
No	Ramp Width (in)	47.5	Yes	Ramp XSlope (%)	1.2
N/A	Flare Type LT	N/A	N/A	Flare Type RT	N/A
N/A	Flare Slope LT (%)	N/A	N/A	Flare Slope RT (%)	N/A
N/A	Flare Traversable LT?	N/A	N/A	Flare Traversable RT?	N/A
N/A	Landing Length (in)	N/A	N/A	DWS Provided?	N/A
N/A	Landing Width (in)	N/A	N/A	DWS Contrast?	N/A
N/A	Landing Slope (%)	N/A	N/A	DWS Length (in)	N/A
N/A	Landing X Slope (%)	N/A	N/A	DWS Full Width?	N/A
N/A	Landing Curb? (Y/N)	N/A	N/A	DWS Offset (in)	N/A
N/A	Shared Landing?	N/A			
N/A	Gutter Ponding?	Yes	N/A	Gutter Slope (%)	N/A
N/A	Gutter Lip Ht (in)	N/A	N/A	Gutter X Slope (%)	N/A
N/A	Painted X Walk1?	No	N/A	Painted X Walk2?	N/A
	X Walk 1 Direction	To E		X Walk 2 Direction	N/A
N/A	X Walk 1 Width (in)	N/A	N/A	X Walk 2 Width (in)	N/A
	X Walk 1 Slope (%)	1.6		X Walk 2 Slope (%)	N/A
	X Walk 1 X Slope (%)	0.3		X Walk 2 X Slope (%)	N/A

Remove & Replace Entire Ramp.
