Access Compliance Report

Public Rights-of-Way

(Curb Ramps)

Intersection ID: 29732	Main Street: JOUSTING_CT	Cross Street: KING_ARTHUR_DR	Location: NW
ADA ID: 345702361269	Ramp Type: PerpDiag	Initial Pass/Fail: Fail	Overall Compliance: No
			Severity Score: 33.75

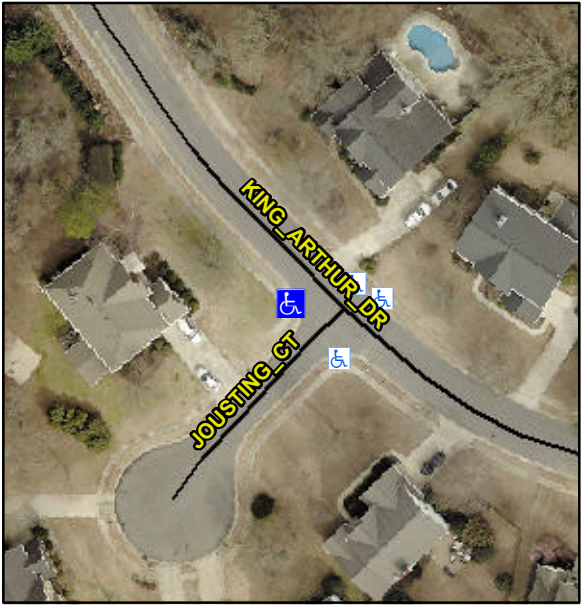
Possible Solutions:		Compliance	Description	Data
	Remove & Replace Curb Ramp With Two New Directional Ramps or Equivalent.		No	Ramp Length (in)	98.0
			No	Ramp Width (in)	45.0
			N/A	Flare Type LT	N/A
			N/A	Flare Slope LT (%)	N/A
			N/A	Flare Traversable LT?	N/A
			N/A	Landing Length (in)	N/A
			N/A	Landing Width (in)	N/A
			N/A	Landing Slope (%)	N/A
			N/A	Landing X Slope (%)	N/A
<p>Surveyor Notes:</p> <p>N/A</p> <p>PROW/ADA:</p> <p>Not Found, R304.5.1, R304.2.2, R304.5.3</p>			N/A	Flare Type RT	N/A
			N/A	Flare Slope RT (%)	N/A
			N/A	Flare Traversable RT?	N/A
			N/A	DWS Provided?	N/A
			N/A	DWS Contrast?	N/A
			N/A	DWS Length (in)	N/A
			N/A	DWS Full Width?	N/A
			N/A	DWS Offset (in)	N/A
			N/A	Gutter Ponding?	N/A
			N/A	Gutter Lip Ht (in)	N/A
			No	Painted X Walk1?	No
				X Walk 1 Direction	To SE
			N/A	X Walk 1 Width (in)	N/A

0.7	X Walk 1 Slope (%)	2.7
			3.7	X Walk 1 X Slope (%)	0.9
			N/A	Ramp inside XWalk1?	N/A
			1.5	Road Slope (%)	N/A
			1.1	Road X Slope (%)	N/A
			N/A	Any Obstructions?	N/A
				Obstruction Type	
Total Cost: \$ 3200.00			N/A	Storm Grate/Utility Hazard?	N/A
			N/A	Storm Grate/Utility Type	N/A
			Yes	Surface Condition? (G/P)	Good
