Access Compliance Report

Public Rights-of-Way

(Curb Ramps)

Intersection ID: 15882	Main Street: EAST_BV	Cross Street: QUEENS_RD_WEST	Location: SE
ADA ID: 345D58F969D0	Ramp Type: Directional1	Initial Pass/Fail: Fail	Overall Compliance: No
Codes/Mitigation Info/Possible Solution		Field Measurements/Component Compliance	
Severity Score: 25

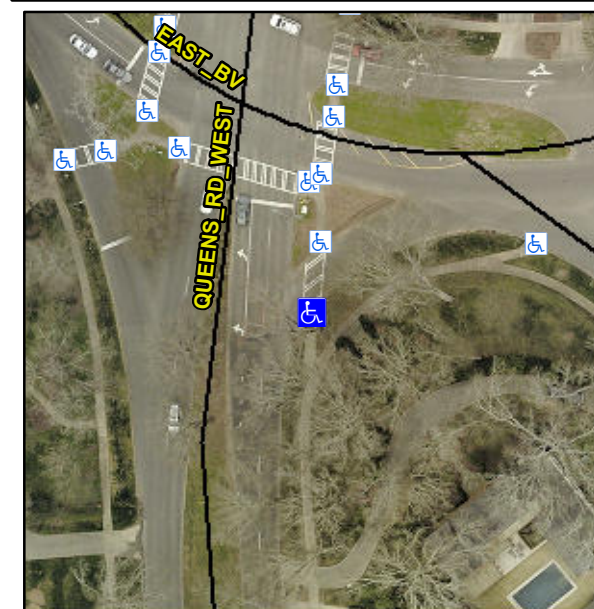
Compliance	Description	Data	Compliance	Description	Data
N/A	Ramp Length (in)	222.0	N/A	Grade Break?	N/A
Yes	Ramp Width (in)	60.0	N/A	Grade Break Slope (%)	0.0
Yes	Ramp Slope (%)	8.1	N/A	Grade Break XSlope (%)	0.0
No	Ramp XSlope (%)	12.1			
N/A	Flare Type LT	N/A	N/A	Flare Type RT	N/A
N/A	Flare Slope LT (%)	N/A	N/A	Flare Slope RT (%)	0.0
N/A	Flare Traversable LT?	N/A	N/A	Flare Traversable RT?	N/A
N/A	Landing Length (in)	0.0	N/A	DWS Provided?	N/A
N/A	Landing Width (in)	0.0	N/A	DWS Contrast?	N/A
N/A	Landing Slope (%)	0.0	N/A	DWS Length (in)	N/A
N/A	Landing X Slope (%)	0.0	N/A	DWS Full Width?	N/A
N/A	Landing Curb? (Y/N)	N/A	N/A	DWS Offset LT (in)	N/A
N/A	Shared Landing?	N/A	N/A	DWS Offset RT (in)	N/A
N/A	Gutter Ponding?	0.0	N/A	Gutter Slope (%)	N/A
N/A	Gutter Lip Ht (in)	0.0	N/A	Gutter X Slope (%)	N/A
N/A	Painted X Walk1?	Yes		Road Slope (%)	0.7
	X Walk 1 Direction	To N		Road X Slope (%)	2.0
	X Walk 1 Width (in)	97.0		Clear Space?	N/A

X Walk 1 Slope (%)	0.7	N/A	Clear Space to XWalk (in)	N/A
	X Walk 1 X Slope (%)	2.0	N/A	Storm Grate/Utility Hazard?	N/A
N/A	Ramp inside XWalk1?	Yes		Storm Grate/Utility Type	
N/A	Any Obstructions?	N/A			N/A
	Obstruction Type		Yes	Surface Condition? (G/P)	Good
			N/A	Curb Slope (%)	4.8

Possible Solutions:

Remove & Replace Entire Ramp.

PROW/ADA:

R304.5.3
