# Access Compliance Report

## Public Rights-of-Way

### (Curb Ramps)

| Intersection ID: 10037649 | Main Street: SEVENTY SEVEN CENTER DR | Cross Street: N/A | Location: SE |

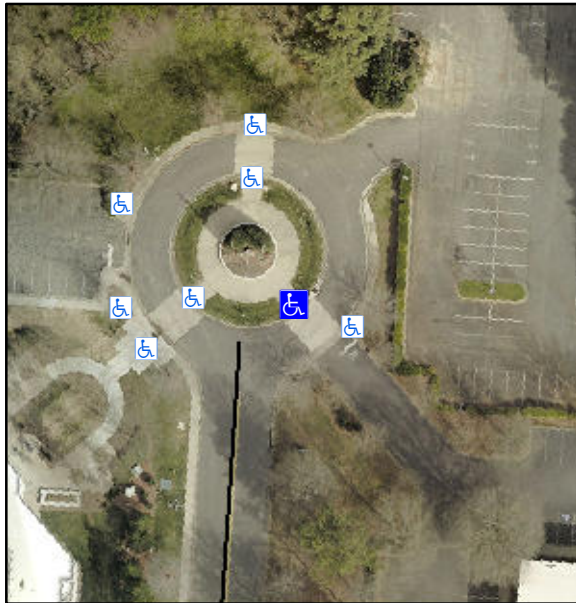
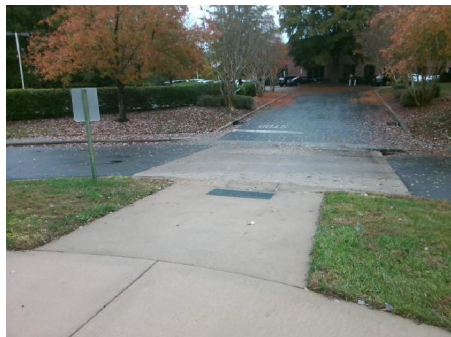
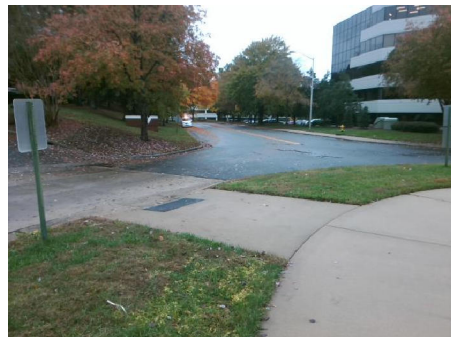
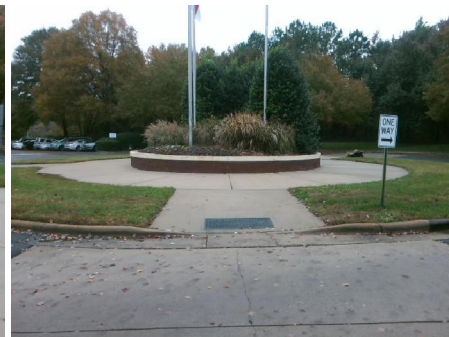
| ADA ID: 3467C298FFC8 | Ramp Type: Perp | Initial Pass/Fail: Fail | Overall Compliance: No |
| Severity Score: 21.25 | | | |

**R304.5.1, R304.2.2**

| Compliance | Description | Data | Compliance | Description | Data |
|---|---|---|---|---|---|
| N/A | Ramp Length (in) | 57.0 | No | Ramp Slope (%) | 9.4 |
| No | Ramp Width (in) | 38.5 | Yes | Ramp XSlope (%) | 1.4 |

**Remove & Replace Entire Ramp.**

**\$ 1850.00**
