Access Compliance Report

Public Rights-of-Way

(Curb Ramps)

Intersection ID: 14049	Main Street: CLEMENT_AV	Cross Street: PARK_DR	Location: SE
ADA ID: 346D8CB46AE6	Ramp Type: BlendTrans2	Initial Pass/Fail: Pass	Overall Compliance: No
		Severity Score: 0

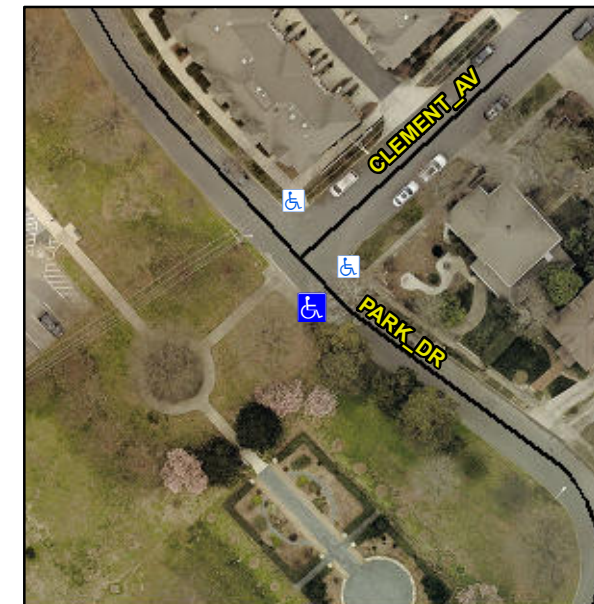
Not Found, R304.2.3

Compliance	Description	Data	Compliance	Description	Data
N/A	Ramp Length (in)	72.5	Yes	BlendTrans Slope (%)	2.2
Yes	Ramp Width (in)	48.0	Yes	BlendTrans XSlope (%)	0.5
N/A	Flare Type LT	Sloped	N/A	Flare Type RT	Sloped
N/A	Flare Slope LT (%)	N/A	No	Flare Slope RT (%)	N/A
N/A	Flare Traversable LT?	No	N/A	Flare Traversable RT?	Yes
N/A	Landing Length (in)	N/A	Yes	DWS Provided?	Yes
N/A	Landing Width (in)	N/A	Yes	DWS Contrast?	Yes
N/A	Landing Slope (%)	N/A	Yes	DWS Length (in)	24.0
N/A	Landing X Slope (%)	N/A	Yes	DWS Full Width?	Yes
N/A	Landing Curb? (Y/N)	No	Yes	DWS Offset (in)	0.0
N/A	Shared Landing?	No			
Yes	Gutter Ponding?	No	Yes	Gutter Slope (%)	0.0
Yes	Gutter Lip Ht (in)	0.0	Yes	Gutter X Slope (%)	1.0
N/A	Painted X Walk1?	No	N/A	Painted X Walk2?	N/A
	X Walk 1 Direction	To NE		X Walk 2 Direction	N/A
	X Walk 1 Width (in)	N/A		X Walk 2 Width (in)	N/A
	X Walk 1 Slope (%)	2.3		X Walk 2 Slope (%)	N/A
	X Walk 1 X Slope (%)	1.3		X Walk 2 X Slope (%)	N/A

N/A	Ramp inside XWalk1?	N/A	N/A	Ramp inside XWalk2?	N/A
	Road Slope (%)	1.3		Clear Space?	Yes
	Road X Slope (%)	2.3	N/A	Clear Space to XWalk (in)	N/A
Yes	Any Obstructions?	No	Yes	Storm Grate/Utility Hazard?	No
	Obstruction Type			Storm Grate/Utility Type	
		N/A			N/A
			Yes	Surface Condition? (G/P)	Good
			No	Curb Slope (%)	7.4

Remove & Replace Curb Ramp With Two New Directional Ramps or Equivalent.
