Access Compliance Report

Public Rights-of-Way (Curb Ramps)

Intersection ID: 13895	Main Street: ELIZABETH_AV	Cross Street: TRAVIS_AV	Location: SE
ADA ID: 347B9119A942	Ramp Type: Perp	Initial Pass/Fail: Fail	Overall Compliance: No
Severity Score: 21.25			
Codes/Mitigation Info/Possible Solution		Field Measurements/Component Compliance

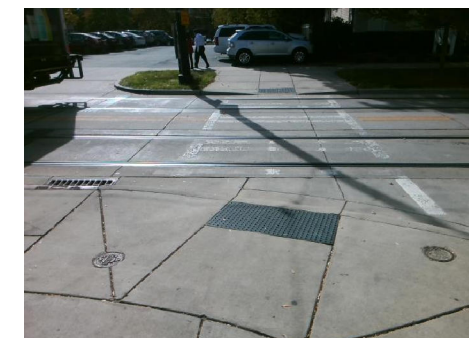
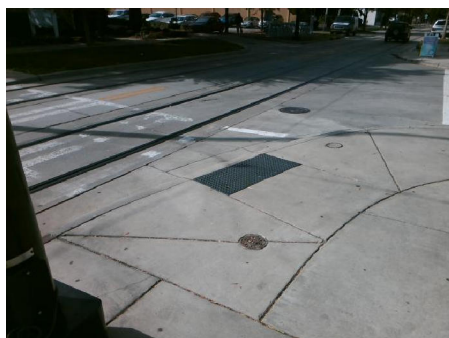
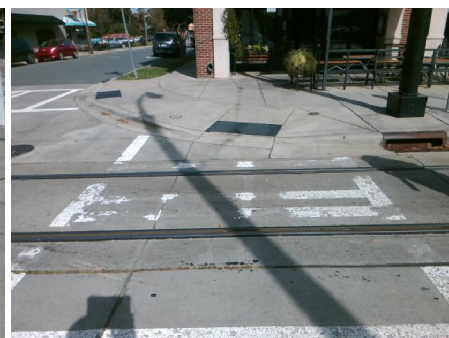
Compliance	Description	Data	Compliance	Description	Data
N/A	Ramp Length (in)	72.0	No	Ramp Slope (%)	8.4
No	Ramp Width (in)	47.5	Yes	Ramp XSlope (%)	0.2
N/A	Flare Type LT	N/A	N/A	Flare Type RT	N/A
N/A	Flare Slope LT (%)	N/A	N/A	Flare Slope RT (%)	N/A
N/A	Flare Traversable LT?	N/A	N/A	Flare Traversable RT?	N/A
N/A	Landing Length (in)	N/A	N/A	DWS Provided?	N/A
N/A	Landing Width (in)	N/A	N/A	DWS Contrast?	N/A
N/A	Landing Slope (%)	N/A	N/A	DWS Length (in)	N/A
N/A	Landing X Slope (%)	N/A	N/A	DWS Full Width?	N/A
N/A	Landing Curb? (Y/N)	N/A	N/A	DWS Offset (in)	N/A
N/A	Shared Landing?	N/A			
N/A	Gutter Ponding?	N/A	N/A	Gutter Slope (%)	N/A
N/A	Gutter Lip Ht (in)	N/A	N/A	Gutter X Slope (%)	N/A
N/A	Painted X Walk1?	Yes	N/A	Painted X Walk2?	N/A
	X Walk 1 Direction	To SW		X Walk 2 Direction	N/A
N/A	X Walk 1 Width (in)	112.0	N/A	X Walk 2 Width (in)	N/A
	X Walk 1 Slope (%)	3.4		X Walk 2 Slope (%)	N/A
	X Walk 1 X Slope (%)	1.5		X Walk 2 X Slope (%)	N/A

N/A	Ramp inside XWalk1?	Yes	N/A	Ramp inside XWalk2?	N/A
	Road Slope (%)	N/A	N/A	Clear Space?	N/A
	Road X Slope (%)	N/A	N/A	Clear Space to XWalk (in)	N/A
N/A	Any Obstructions?	N/A	N/A	Storm Grate/Utility Hazard?	N/A
	Obstruction Type			Storm Grate/Utility Type	
		N/A			N/A
		Yes		Surface Condition? (G/P)	Good

Remove & Replace Entire Ramp.

Not Found, R304.5.1, R304.2.2
