Access Compliance Report Public Rights-of-Way (Curb Ramps)

Intersection ID: 10019937Main Street: ARDREY_KELL_RDCross Street: N/ALocation:NEADA ID: 347C8B8C3C97Ramp Type: ParaInitial Pass/Fail: FailOverall Compliance: NoSeverity Score: 26.25

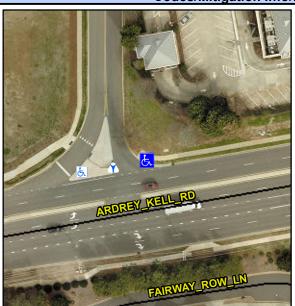
| Compliance Description Data Compliance Description Data | | | | | |
|---|---|---|---|---|---|
| No | Ramp Slope LT (%) | 8.5 | No | Ramp Slope RT (%) | 14.3 |
| No | Ramp XSlope LT (%) | 2.1 | Yes | Ramp XSlope RT (%) | 1.8 |

Remove & Replace Entire Ramp.

R304.3.2, R304.5.3
