# Access Compliance Report

## Public Rights-of-Way

### (Curb Ramps)

Intersection ID: 3908	Main Street: BULLE ROCK CT	Cross Street: WOODCOCK LN	Location: NE
ADA ID: 348172DFFA59	Ramp Type: Perp	Initial Pass/Fail: Fail	Overall Compliance: No
		Severity Score: 12.5

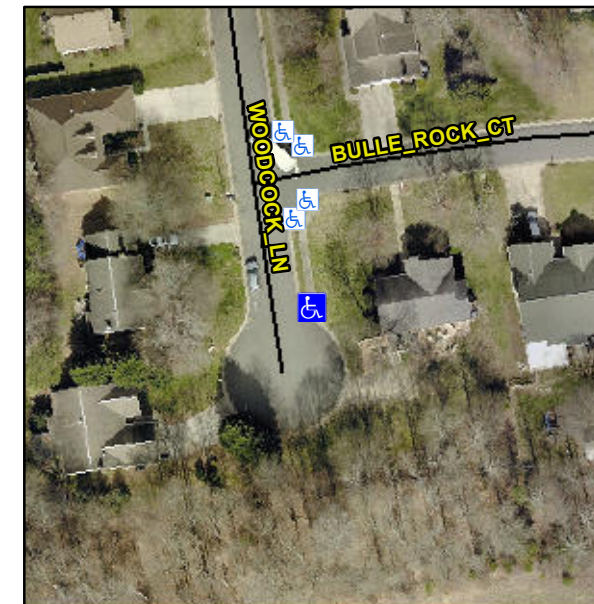
Compliance	Description	Data	Compliance	Description	Data
N/A	Ramp Length (in)	52.0	No	Ramp Slope (%)	8.4
Yes	Ramp Width (in)	52.0	Yes	Ramp XSlope (%)	1.8
N/A	Flare Type LT	N/A	N/A	Flare Type RT	N/A
N/A	Flare Slope LT (%)	N/A	N/A	Flare Slope RT (%)	N/A
N/A	Flare Traversable LT?	N/A	N/A	Flare Traversable RT?	N/A
N/A	Landing Length (in)	N/A	N/A	DWS Provided?	N/A
N/A	Landing Width (in)	N/A	N/A	DWS Contrast?	N/A
N/A	Landing Slope (%)	N/A	N/A	DWS Length (in)	N/A
N/A	Landing X Slope (%)	N/A	N/A	DWS Full Width?	N/A
N/A	Landing Curb? (Y/N)	N/A	N/A	DWS Offset (in)	N/A
N/A	Shared Landing?	N/A			
N/A	Gutter Ponding?	N/A	N/A	Gutter Slope (%)	N/A
N/A	Gutter Lip Ht (in)	N/A	N/A	Gutter X Slope (%)	N/A
N/A	Painted X Walk1?	No	N/A	Painted X Walk2?	N/A
	X Walk 1 Direction	To S		X Walk 2 Direction	N/A
N/A	X Walk 1 Width (in)	N/A	N/A	X Walk 2 Width (in)	N/A
	X Walk 1 Slope (%)	6.0		X Walk 2 Slope (%)	N/A
	X Walk 1 X Slope (%)	0.2		X Walk 2 X Slope (%)	N/A

N/A	Ramp inside XWalk1?	N/A	N/A	Ramp inside XWalk2?	N/A
	Road Slope (%)	0.2	N/A	Clear Space?	N/A
	Road X Slope (%)	6.0	N/A	Clear Space to XWalk (in)	N/A
N/A	Any Obstructions?	N/A	N/A	Storm Grate/Utility Hazard?	N/A
	Obstruction Type			Storm Grate/Utility Type	
		N/A			N/A
			Yes	Surface Condition? (G/P)	Good

**Remove & Replace Entire Ramp.**

**R304.2.2**

Total Cost: \$ 1850.00
