Access Compliance Report

Public Rights-of-Way

(Curb Ramps)

Intersection ID: 44487	Main Street: REAMES_RD	Cross Street: FINN_HALL_AV	Location: S
ADA ID: 3487C75D3899	Ramp Type: Perp	Initial Pass/Fail: Fail	Overall Compliance: No
Codes/Mitigation Info/Possible Solution		Field Measurements/Component Compliance	
Severity Score: 33.75

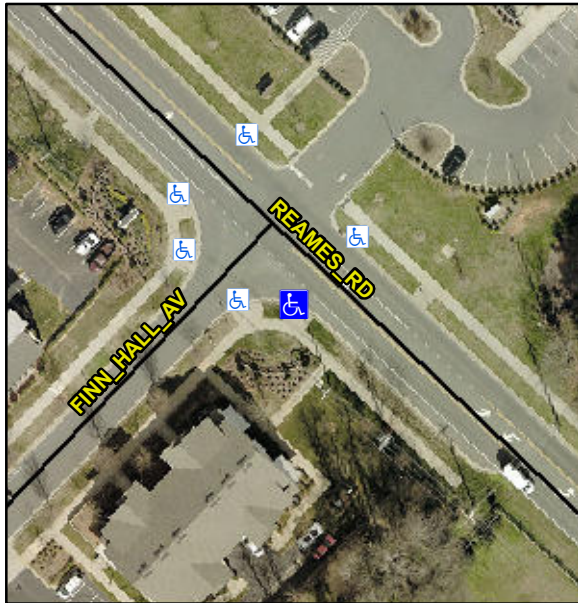
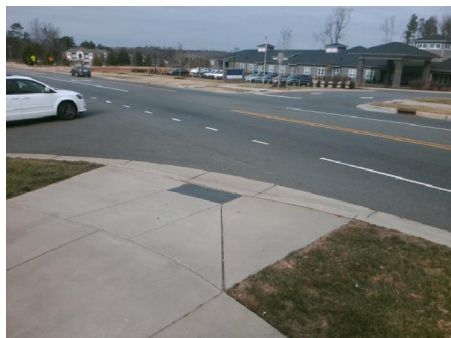
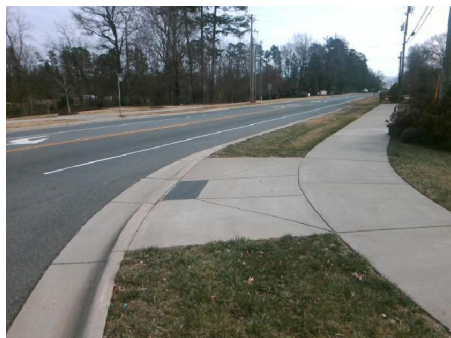
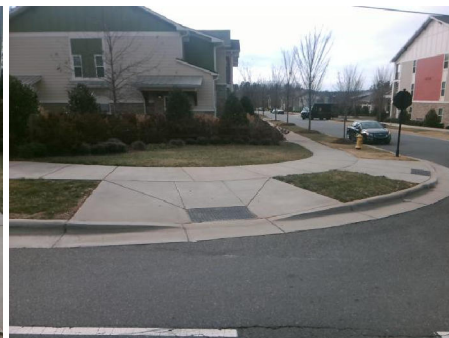
Not Found, R304.5.1, R304.5.3

Compliance	Description	Data	Compliance	Description	Data
N/A	Ramp Length (in)	94.5	Yes	Ramp Slope (%)	8.2
No	Ramp Width (in)	45.0	No	Ramp XSlope (%)	8.0
N/A	Flare Type LT	N/A	N/A	Flare Type RT	N/A
N/A	Flare Slope LT (%)	N/A	N/A	Flare Slope RT (%)	N/A
N/A	Flare Traversable LT?	N/A	N/A	Flare Traversable RT?	N/A
N/A	Landing Length (in)	N/A	N/A	DWS Provided?	N/A
N/A	Landing Width (in)	N/A	N/A	DWS Contrast?	N/A
N/A	Landing Slope (%)	N/A	N/A	DWS Length (in)	N/A
N/A	Landing X Slope (%)	N/A	N/A	DWS Full Width?	N/A
N/A	Landing Curb? (Y/N)	N/A	N/A	DWS Offset (in)	N/A
N/A	Shared Landing?	N/A			
N/A	Gutter Ponding?	N/A	N/A	Gutter Slope (%)	N/A
N/A	Gutter Lip Ht (in)	N/A	N/A	Gutter X Slope (%)	N/A
N/A	Painted X Walk1?	No	N/A	Painted X Walk2?	N/A
	X Walk 1 Direction	To NE		X Walk 2 Direction	N/A
N/A	X Walk 1 Width (in)	N/A	N/A	X Walk 2 Width (in)	N/A
	X Walk 1 Slope (%)	2.4		X Walk 2 Slope (%)	N/A
	X Walk 1 X Slope (%)	3.1		X Walk 2 X Slope (%)	N/A

N/A	Ramp inside XWalk1?	N/A	N/A	Ramp inside XWalk2?	N/A
	Road Slope (%)	N/A	N/A	Clear Space?	N/A
	Road X Slope (%)	N/A	N/A	Clear Space to XWalk (in)	N/A
N/A	Any Obstructions?	N/A	N/A	Storm Grate/Utility Hazard?	N/A
	Obstruction Type			Storm Grate/Utility Type	
		N/A			N/A
			Yes	Surface Condition? (G/P)	Good

Possible Solutions:

Remove & Replace Entire Ramp.
