# Access Compliance Report

## Public Rights-of-Way

### (Curb Ramps)

Intersection ID: 19678	Main Street: S_TRYON_ST	Cross Street: OLDE_WHITEHALL_RD	Location: NW
ADA ID: 348A9E111292	Ramp Type: PerpDiag	Initial Pass/Fail: Fail	Overall Compliance: No
		Severity Score: 12.5

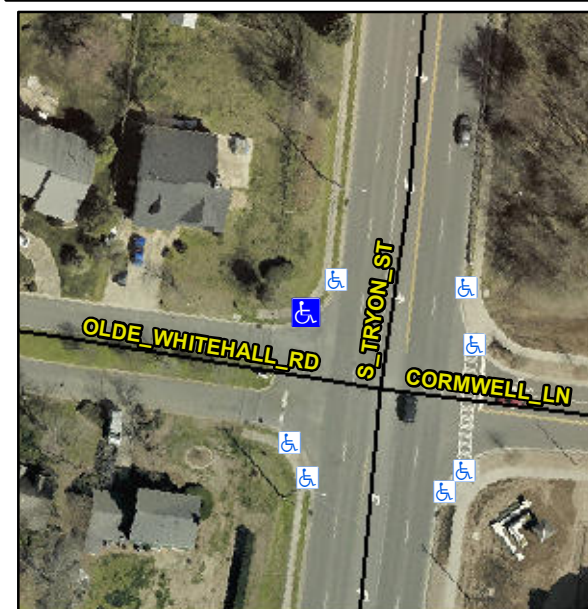
Compliance	Description	Data	Compliance	Description	Data
N/A	Ramp Length (in)	90.0	No	Ramp Slope (%)	8.8
Yes	Ramp Width (in)	48.0	Yes	Ramp XSlope (%)	0.1
N/A	Flare Type LT	N/A	N/A	Flare Type RT	N/A
N/A	Flare Slope LT (%)	N/A	N/A	Flare Slope RT (%)	N/A
N/A	Flare Traversable LT?	N/A	N/A	Flare Traversable RT?	N/A
N/A	Landing Length (in)	N/A	N/A	DWS Provided?	N/A
N/A	Landing Width (in)	N/A	N/A	DWS Contrast?	N/A
N/A	Landing Slope (%)	N/A	N/A	DWS Length (in)	N/A
N/A	Landing X Slope (%)	N/A	N/A	DWS Full Width?	N/A
N/A	Landing Curb? (Y/N)	N/A	N/A	DWS Offset (in)	N/A
N/A	Shared Landing?	N/A			
N/A	Gutter Ponding?	N/A	N/A	Gutter Slope (%)	N/A
N/A	Gutter Lip Ht (in)	N/A	N/A	Gutter X Slope (%)	N/A
N/A	Painted X Walk1?	No	N/A	Painted X Walk2?	No
	X Walk 1 Direction	To S		X Walk 2 Direction	To E
N/A	X Walk 1 Width (in)	N/A	N/A	X Walk 2 Width (in)	N/A
	X Walk 1 Slope (%)	2.9		X Walk 2 Slope (%)	2.4
	X Walk 1 X Slope (%)	2.6		X Walk 2 X Slope (%)	0.3

N/A	Ramp inside XWalk1?	N/A	N/A	Ramp inside XWalk2?	N/A
	Road Slope (%)	0.4	N/A	Clear Space?	N/A
	Road X Slope (%)	2.6	N/A	Clear Space to XWalk (in)	N/A
N/A	Any Obstructions?	N/A	N/A	Storm Grate/Utility Hazard?	N/A
	Obstruction Type			Storm Grate/Utility Type	
		N/A			N/A
			Yes	Surface Condition? (G/P)	Good

**Remove & Replace Curb Ramp With Two New Directional Ramps or Equivalent.**
