Access Compliance Report

Public Rights-of-Way

(Curb Ramps)

Intersection ID: 10033987	Main Street: PARK_RD	Cross Street: N/A	Location: NW
ADA ID: 348BA0080DB8	Ramp Type: Directional1	Initial Pass/Fail: Fail	Overall Compliance: No
		Severity Score: 1.25

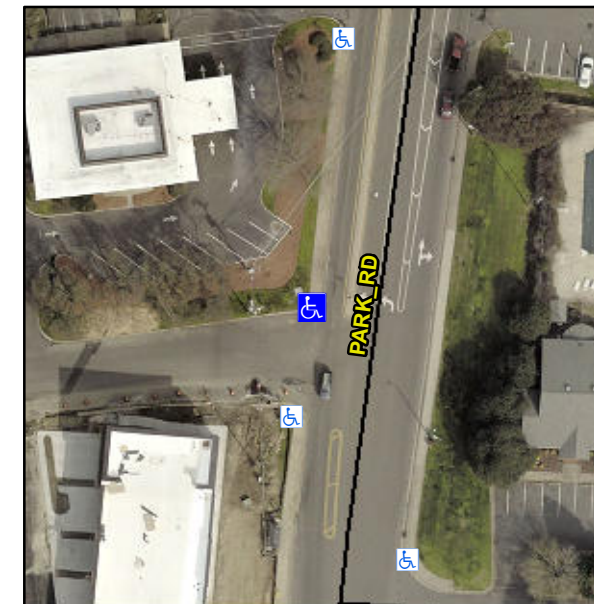
Compliance	Description	Data	Compliance	Description	Data
N/A	Ramp Length (in)	52.5	N/A	Grade Break?	N/A
Yes	Ramp Width (in)	48.0	N/A	Grade Break Slope (%)	0.0
Yes	Ramp Slope (%)	3.8	N/A	Grade Break XSlope (%)	0.0
No	Ramp XSlope (%)	2.8			
N/A	Flare Type LT	N/A	N/A	Flare Type RT	N/A
N/A	Flare Slope LT (%)	N/A	N/A	Flare Slope RT (%)	0.0
N/A	Flare Traversable LT?	N/A	N/A	Flare Traversable RT?	N/A
N/A	Landing Length (in)	0.0	N/A	DWS Provided?	N/A
N/A	Landing Width (in)	0.0	N/A	DWS Contrast?	N/A
N/A	Landing Slope (%)	0.0	N/A	DWS Length (in)	N/A
N/A	Landing X Slope (%)	0.0	N/A	DWS Full Width?	N/A
N/A	Landing Curb? (Y/N)	N/A	N/A	DWS Offset LT (in)	N/A
N/A	Shared Landing?	N/A	N/A	DWS Offset RT (in)	N/A
N/A	Gutter Ponding?	0.0	N/A	Gutter Slope (%)	N/A
N/A	Gutter Lip Ht (in)	0.0	N/A	Gutter X Slope (%)	N/A
N/A	Painted X Walk1?	No		Road Slope (%)	1.1
	X Walk 1 Direction	To S		Road X Slope (%)	1.7
	X Walk 1 Width (in)	N/A		Clear Space?	N/A

X Walk 1 Slope (%)	1.1	N/A	Clear Space to XWalk (in)	N/A
	X Walk 1 X Slope (%)	1.7	N/A	Storm Grate/Utility Hazard?	N/A
N/A	Ramp inside XWalk1?	N/A		Storm Grate/Utility Type	
N/A	Any Obstructions?	N/A			N/A
	Obstruction Type		Yes	Surface Condition? (G/P)	Good
			N/A	Curb Slope (%)	5.5

Possible Solutions:

Remove & Replace Entire Ramp.
