# Access Compliance Report

## Public Rights-of-Way

### (Curb Ramps)

Intersection ID: 10035753	Main Street: REGENCY_EXECUTIVE_PARK_DR	Cross Street: N/A	Location: N
ADA ID: 3493523DFD2B	Ramp Type: Perp	Initial Pass/Fail: Fail	Overall Compliance: No
Severity Score: 61.25			
Codes/Mitigation Info/Possible Solution		Field Measurements/Component Compliance

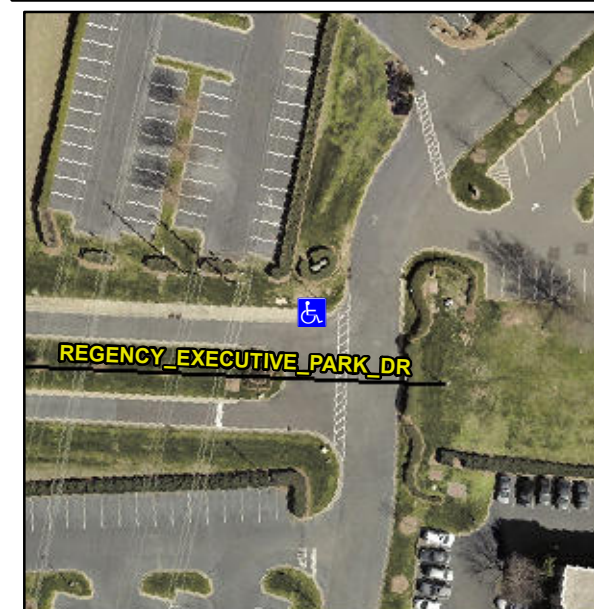
**Not Found, R304.5.1, R304.2.2, R304.5.3**

Compliance	Description	Data	Compliance	Description	Data
N/A	Ramp Length (in)	59.0	No	Ramp Slope (%)	12.8
No	Ramp Width (in)	28.0	No	Ramp XSlope (%)	3.9
N/A	Flare Type LT	N/A	N/A	Flare Type RT	N/A
N/A	Flare Slope LT (%)	N/A	N/A	Flare Slope RT (%)	N/A
N/A	Flare Traversable LT?	N/A	N/A	Flare Traversable RT?	N/A
N/A	Landing Length (in)	N/A	N/A	DWS Provided?	N/A
N/A	Landing Width (in)	N/A	N/A	DWS Contrast?	N/A
N/A	Landing Slope (%)	N/A	N/A	DWS Length (in)	N/A
N/A	Landing X Slope (%)	N/A	N/A	DWS Full Width?	N/A
N/A	Landing Curb? (Y/N)	N/A	N/A	DWS Offset (in)	N/A
N/A	Shared Landing?	N/A			
N/A	Gutter Ponding?	N/A	N/A	Gutter Slope (%)	N/A
N/A	Gutter Lip Ht (in)	N/A	N/A	Gutter X Slope (%)	N/A
N/A	Painted X Walk1?	No	N/A	Painted X Walk2?	N/A
	X Walk 1 Direction	To S		X Walk 2 Direction	N/A
N/A	X Walk 1 Width (in)	N/A	N/A	X Walk 2 Width (in)	N/A
	X Walk 1 Slope (%)	2.3		X Walk 2 Slope (%)	N/A
	X Walk 1 X Slope (%)	4.2		X Walk 2 X Slope (%)	N/A

N/A	Ramp inside XWalk1?	N/A	N/A	Ramp inside XWalk2?	N/A
	Road Slope (%)	N/A	N/A	Clear Space?	N/A
	Road X Slope (%)	N/A	N/A	Clear Space to XWalk (in)	N/A
N/A	Any Obstructions?	N/A	N/A	Storm Grate/Utility Hazard?	N/A
	Obstruction Type			Storm Grate/Utility Type	
		N/A			N/A
			Yes	Surface Condition? (G/P)	Good

Possible Solutions:

**Remove & Replace Entire Ramp.**
