Access Compliance Report

Public Rights-of-Way

(Curb Ramps)

Intersection ID: 11122	Main Street: N_CHURCH_ST	Cross Street: W_15TH_ST	Location: E
ADA ID: 3494A3190893	Ramp Type: Perp	Initial Pass/Fail: Fail	Overall Compliance: No
Severity Score: 22.5			
Codes/Mitigation Info/Possible Solution		Field Measurements/Component Compliance

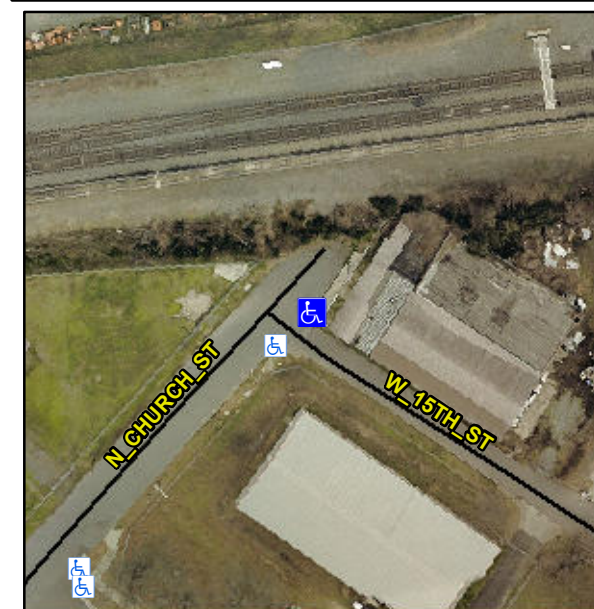
Compliance	Description	Data	Compliance	Description	Data
N/A	Ramp Length (in)	33.0	No	Ramp Slope (%)	9.1
No	Ramp Width (in)	44.0	Yes	Ramp XSlope (%)	2.6
N/A	Flare Type LT	N/A	N/A	Flare Type RT	N/A
N/A	Flare Slope LT (%)	N/A	N/A	Flare Slope RT (%)	N/A
N/A	Flare Traversable LT?	N/A	N/A	Flare Traversable RT?	N/A
N/A	Landing Length (in)	N/A	N/A	DWS Provided?	N/A
N/A	Landing Width (in)	N/A	N/A	DWS Contrast?	N/A
N/A	Landing Slope (%)	N/A	N/A	DWS Length (in)	N/A
N/A	Landing X Slope (%)	N/A	N/A	DWS Full Width?	N/A
N/A	Landing Curb? (Y/N)	N/A	N/A	DWS Offset (in)	N/A
N/A	Shared Landing?	N/A			
N/A	Gutter Ponding?	N/A	N/A	Gutter Slope (%)	N/A
N/A	Gutter Lip Ht (in)	N/A	N/A	Gutter X Slope (%)	N/A
N/A	Painted X Walk1?	No	N/A	Painted X Walk2?	N/A
	X Walk 1 Direction	To SW		X Walk 2 Direction	N/A
N/A	X Walk 1 Width (in)	N/A	N/A	X Walk 2 Width (in)	N/A
	X Walk 1 Slope (%)	0.3		X Walk 2 Slope (%)	N/A
	X Walk 1 X Slope (%)	5.7		X Walk 2 X Slope (%)	N/A

N/A	Ramp inside XWalk1?	N/A	N/A	Ramp inside XWalk2?	N/A
	Road Slope (%)	N/A	N/A	Clear Space?	N/A
	Road X Slope (%)	N/A	N/A	Clear Space to XWalk (in)	N/A
N/A	Any Obstructions?	N/A	N/A	Storm Grate/Utility Hazard?	N/A
	Obstruction Type			Storm Grate/Utility Type	
		N/A			N/A
			Yes	Surface Condition? (G/P)	Good

Possible Solutions:

Remove & Replace Entire Ramp.

R304.5.1, R304.2.2

\$ 1850.00
