# Access Compliance Report

## Public Rights-of-Way

### (Curb Ramps)

Intersection ID: 9690	Main Street: NORWOOD_DR	Cross Street: PARKWAY_AV	Location:	N
ADA ID: 349F99E7991C	Ramp Type: Perp	Initial Pass/Fail: Fail	Overall Compliance: No	Severity Score: 26.25
Codes/Mitigation Info/Possible Solution		Field Measurements/Component Compliance

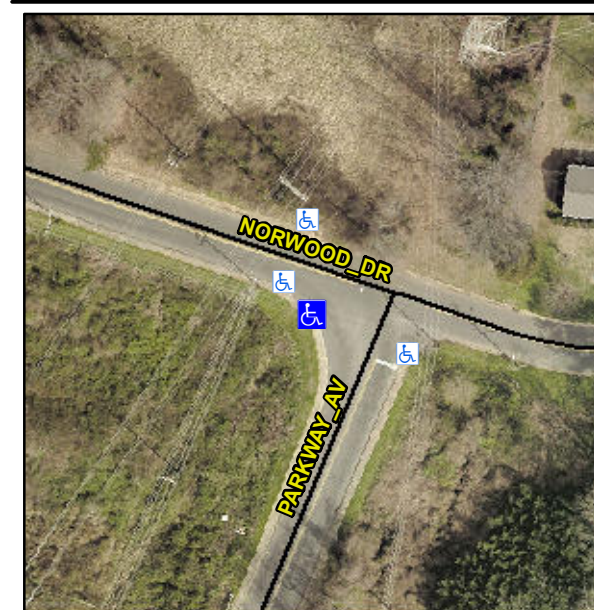
**Not Found, R304.2.2, R304.5.3**

Compliance	Description	Data	Compliance	Description	Data
N/A	Ramp Length (in)	40.5	No	Ramp Slope (%)	14.5
Yes	Ramp Width (in)	49.0	No	Ramp XSlope (%)	4.5
N/A	Flare Type LT	N/A	N/A	Flare Type RT	N/A
N/A	Flare Slope LT (%)	N/A	N/A	Flare Slope RT (%)	N/A
N/A	Flare Traversable LT?	N/A	N/A	Flare Traversable RT?	N/A
N/A	Landing Length (in)	N/A	N/A	DWS Provided?	N/A
N/A	Landing Width (in)	N/A	N/A	DWS Contrast?	N/A
N/A	Landing Slope (%)	N/A	N/A	DWS Length (in)	N/A
N/A	Landing X Slope (%)	N/A	N/A	DWS Full Width?	N/A
N/A	Landing Curb? (Y/N)	N/A	N/A	DWS Offset (in)	N/A
N/A	Shared Landing?	N/A			
N/A	Gutter Ponding?	N/A	N/A	Gutter Slope (%)	N/A
N/A	Gutter Lip Ht (in)	N/A	N/A	Gutter X Slope (%)	N/A
N/A	Painted X Walk1?	No	N/A	Painted X Walk2?	N/A
	X Walk 1 Direction	To SE		X Walk 2 Direction	N/A
N/A	X Walk 1 Width (in)	N/A	N/A	X Walk 2 Width (in)	N/A
	X Walk 1 Slope (%)	2.2		X Walk 2 Slope (%)	N/A
	X Walk 1 X Slope (%)	1.9		X Walk 2 X Slope (%)	N/A

N/A	Ramp inside XWalk1?	N/A	N/A	Ramp inside XWalk2?	N/A
	Road Slope (%)	N/A	N/A	Clear Space?	N/A
	Road X Slope (%)	N/A	N/A	Clear Space to XWalk (in)	N/A
N/A	Any Obstructions?	N/A	N/A	Storm Grate/Utility Hazard?	N/A
	Obstruction Type			Storm Grate/Utility Type	
		N/A			N/A
			Yes	Surface Condition? (G/P)	Good

**Remove & Replace Entire Ramp.**

Total Cost: \$ 1850.00
