Access Compliance Report

(Curb Ramps)

| Intersection ID: 22022 | Main Street: HAMPTONRIDGE_DR | Cross Street: HEATHSTEAD_PL | Location: NE |
| ADA ID: 34A1ED940C64 | Ramp Type: PerpDiag | Initial Pass/Fail: Fail | Overall Compliance: No |

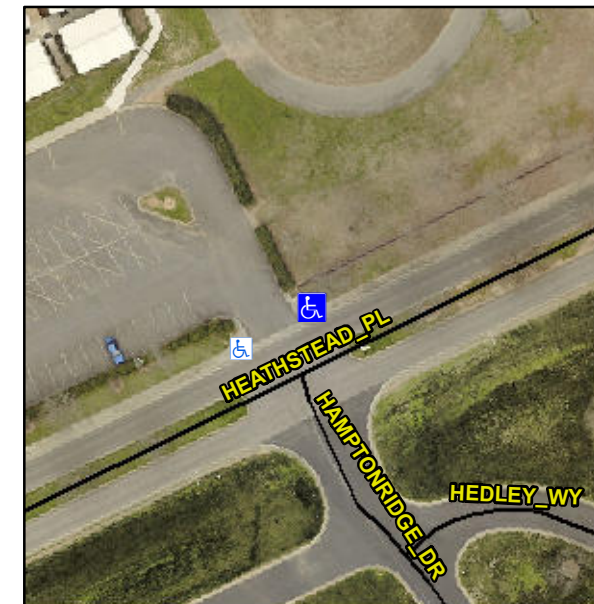
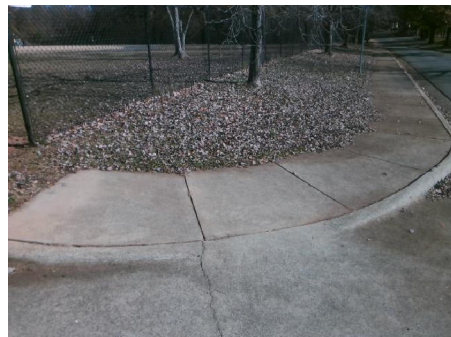
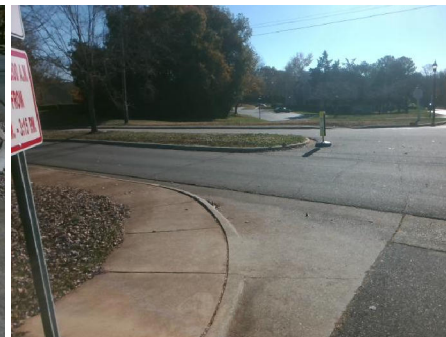
Not Found, R304.5.3

| Compliance | Description | Data | Compliance | Description | Data |
|---|---|---|---|---|---|
| N/A | Ramp Length (in) | 58.0 | Yes | Ramp Slope (%) | 5.7 |
| Yes | Ramp Width (in) | 50.0 | No | Ramp XSlope (%) | 5.1 |

Remove & Replace Curb Ramp With Two New Directional Ramps or Equivalent.
