# Access Compliance Report

## Public Rights-of-Way

### (Curb Ramps)

Intersection ID: 13743	Main Street: DR_CARVER_RD	Cross Street: WEST_BV	Location: NE
ADA ID: 34AB5E1D9A68	Ramp Type: BlendTrans1	Initial Pass/Fail: Fail	Overall Compliance: No
		Severity Score: 30

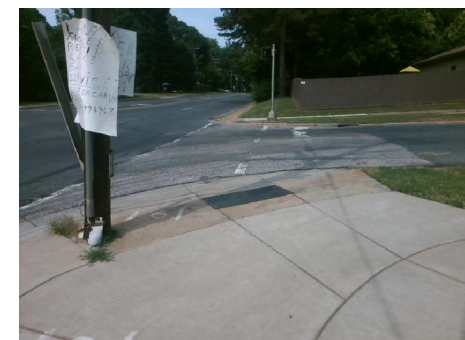
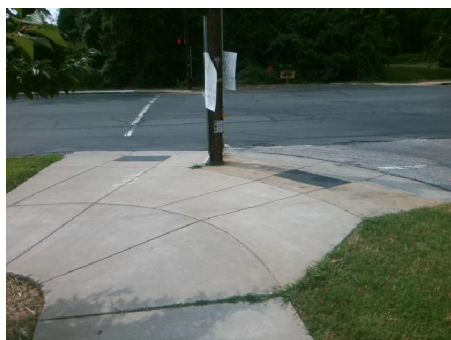
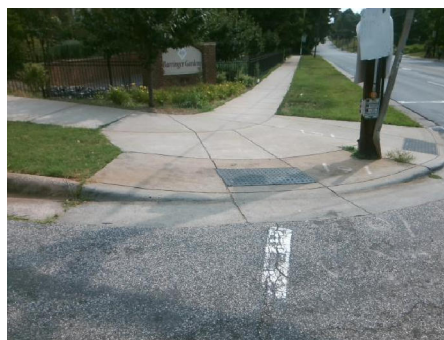
Compliance	Description	Data	Compliance	Description	Data
N/A	Ramp Length (in)	114.0	No	BlendTrans Slope (%)	10.9
No	Ramp Width (in)	32.0	Yes	BlendTrans XSlope (%)	1.8
N/A	Flare Type LT	N/A	N/A	Flare Type RT	N/A
N/A	Flare Slope LT (%)	N/A	N/A	Flare Slope RT (%)	N/A
N/A	Flare Traversable LT?	N/A	N/A	Flare Traversable RT?	N/A
N/A	Landing Length (in)	N/A	N/A	DWS Provided?	N/A
N/A	Landing Width (in)	N/A	N/A	DWS Contrast?	N/A
N/A	Landing Slope (%)	N/A	N/A	DWS Length (in)	N/A
N/A	Landing X Slope (%)	N/A	N/A	DWS Full Width?	N/A
N/A	Landing Curb? (Y/N)	N/A	N/A	DWS Offset (in)	N/A
N/A	Shared Landing?	N/A			
N/A	Gutter Ponding?	N/A	N/A	Gutter Slope (%)	N/A
N/A	Gutter Lip Ht (in)	N/A	N/A	Gutter X Slope (%)	N/A
N/A	Painted X Walk1?	Yes	N/A	Painted X Walk2?	N/A
	X Walk 1 Direction	To SW		X Walk 2 Direction	N/A
	X Walk 1 Width (in)	108.0		X Walk 2 Width (in)	N/A
	X Walk 1 Slope (%)	0.8		X Walk 2 Slope (%)	N/A
	X Walk 1 X Slope (%)	8.3		X Walk 2 X Slope (%)	N/A

N/A	Ramp inside XWalk1?	No	N/A	Ramp inside XWalk2?	N/A
	Road Slope (%)	8.3		Clear Space?	N/A
	Road X Slope (%)	0.8	N/A	Clear Space to XWalk (in)	N/A
N/A	Any Obstructions?	N/A	N/A	Storm Grate/Utility Hazard?	N/A
	Obstruction Type			Storm Grate/Utility Type	
		N/A			N/A
			Yes	Surface Condition? (G/P)	Good
			N/A	Curb Slope (%)	0.7

**Remove & Replace Curb Ramp With Two New Directional Ramps or Equivalent. Restripe Crosswalk.**

**R304.5.1, R304.4.1**
