Access Compliance Report

Public Rights-of-Way

(Curb Ramps)

Intersection ID: 10012837	Main Street: CENTRAL_AV	Cross Street: N/A	Location: SE
ADA ID: 34B8443D684B	Ramp Type: PerpDiag	Initial Pass/Fail: Fail	Overall Compliance: No
			Severity Score: 48.75

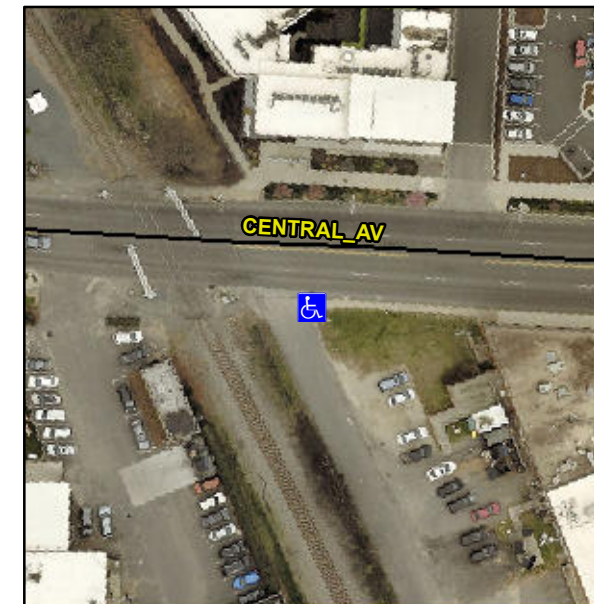
Not Found, R304.5.1, R304.2.2

Compliance	Description	Data	Compliance	Description	Data
N/A	Ramp Length (in)	56.0	No	Ramp Slope (%)	9.7
No	Ramp Width (in)	26.0	Yes	Ramp XSlope (%)	2.9
N/A	Flare Type LT	N/A	N/A	Flare Type RT	N/A
N/A	Flare Slope LT (%)	N/A	N/A	Flare Slope RT (%)	N/A
N/A	Flare Traversable LT?	N/A	N/A	Flare Traversable RT?	N/A
N/A	Landing Length (in)	N/A	N/A	DWS Provided?	N/A
N/A	Landing Width (in)	N/A	N/A	DWS Contrast?	N/A
N/A	Landing Slope (%)	N/A	N/A	DWS Length (in)	N/A
N/A	Landing X Slope (%)	N/A	N/A	DWS Full Width?	N/A
N/A	Landing Curb? (Y/N)	N/A	N/A	DWS Offset (in)	N/A
N/A	Shared Landing?	N/A			
N/A	Gutter Ponding?	N/A	N/A	Gutter Slope (%)	N/A
N/A	Gutter Lip Ht (in)	N/A	N/A	Gutter X Slope (%)	N/A
N/A	Painted X Walk1?	No	N/A	Painted X Walk2?	No
	X Walk 1 Direction	To N		X Walk 2 Direction	To W
N/A	X Walk 1 Width (in)	N/A	N/A	X Walk 2 Width (in)	N/A
	X Walk 1 Slope (%)	7.6		X Walk 2 Slope (%)	4.7
	X Walk 1 X Slope (%)	4.0		X Walk 2 X Slope (%)	4.3

N/A	Ramp inside XWalk1?	N/A	N/A	Ramp inside XWalk2?	N/A
	Road Slope (%)	5.8	N/A	Clear Space?	N/A
	Road X Slope (%)	1.7	N/A	Clear Space to XWalk (in)	N/A
N/A	Any Obstructions?	N/A	N/A	Storm Grate/Utility Hazard?	N/A
	Obstruction Type			Storm Grate/Utility Type	
		N/A			N/A
			Yes	Surface Condition? (G/P)	Good

Possible Solutions:

Remove & Replace Curb Ramp With Two New Directional Ramps or Equivalent.
