# Access Compliance Report

## Public Rights-of-Way

### (Curb Ramps)

| Intersection ID: 43838 | Main Street: DELUCA_DR | Cross Street: ROBINSON_CHURCH_RD | Location: NW |

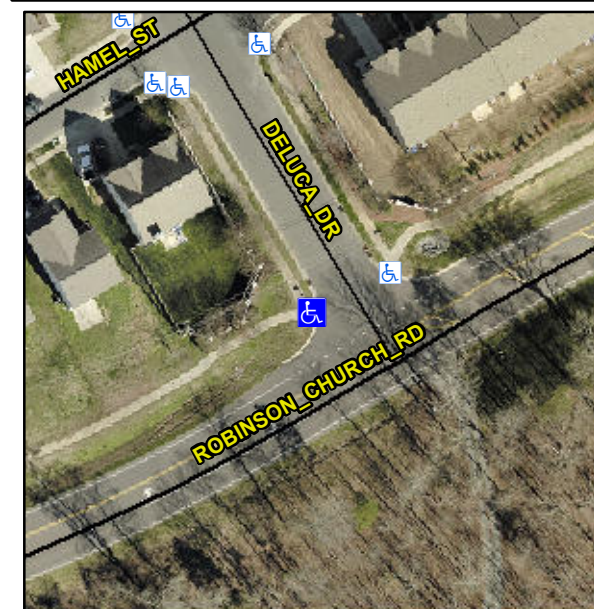
**Not Found, R304.5.1, R304.5.3**

| Compliance | Description | Data | Compliance | Description | Data |
|---|---|---|---|---|---|
| N/A | Ramp Length (in) | 47.0 | Yes | Ramp Slope (%) | 5.5 |
| No | Ramp Width (in) | 47.5 | No | Ramp XSlope (%) | 3.5 |

**Remove & Replace Entire Ramp.**

Total Cost: \$ 1850.00
