Access Compliance Report

Public Rights-of-Way

(Curb Ramps)

Intersection ID: 10040781	Main Street: W_TYVOLA_RD	Cross Street: N/A	Location: SE
ADA ID: 34BA9D5CBE1B	Ramp Type: ParaDiag	Initial Pass/Fail: Fail	Overall Compliance: No
Severity Score: 12.5			
Codes/Mitigation Info/Possible Solution		Field Measurements/Component Compliance

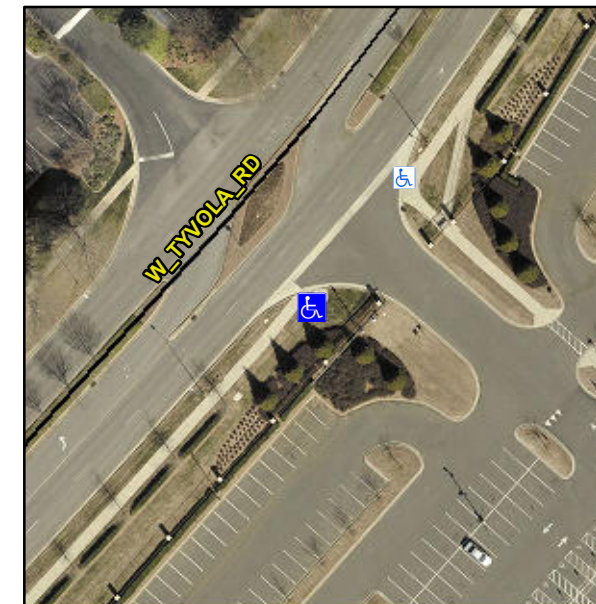
MEDIAN ACROSS W TYVOLA RD

Compliance	Description	Data	Compliance	Description	Data
N/A	Ramp Length LT (in)	84.0	N/A	Ramp Length RT (in)	59.0
Yes	Ramp Width LT (in)	77.5	Yes	Ramp Width RT (in)	80.0
No	Ramp Slope LT (%)	9.0	Yes	Ramp Slope RT (%)	5.7
Yes	Ramp XSlope LT (%)	1.4	Yes	Ramp XSlope RT (%)	0.2
N/A	Landing Length (in)	N/A	N/A	DWS Provided?	N/A
N/A	Landing Width (in)	N/A	N/A	DWS Contrast?	N/A
N/A	Landing Slope (%)	N/A	N/A	DWS Length (in)	N/A
N/A	Landing X Slope (%)	N/A	N/A	DWS Full Width?	N/A
N/A	Landing Curb? (Y/N)	N/A	N/A	DWS Offset (in)	N/A
N/A	Shared Landing?	N/A			
N/A	Gutter Ponding?	N/A	N/A	Gutter Slope (%)	N/A
N/A	Gutter Lip Ht (in)	N/A	N/A	Gutter X Slope (%)	N/A
N/A	Painted X Walk1?	No	N/A	Painted X Walk2?	No
	X Walk 1 Direction	To NE		X Walk 2 Direction	To NW
N/A	X Walk 1 Width (in)	N/A	N/A	X Walk 2 Width (in)	N/A
	X Walk 1 Slope (%)	1.4		X Walk 2 Slope (%)	4.9
	X Walk 1 X Slope (%)	1.7		X Walk 2 X Slope (%)	3.4
N/A	Ramp inside XWalk1?	N/A	N/A	Ramp inside XWalk2?	N/A

Road Slope (%)	1.3	N/A	Clear Space?	N/A
	Road X Slope (%)	0.3	N/A	Clear Space to XWalk (in)	N/A
N/A	Any Obstructions?	N/A	N/A	Storm Grate/Utility Hazard?	N/A
	Obstruction Type			Storm Grate/Utility Type	
		N/A			N/A
			Yes	Surface Condition? (G/P)	Good
			N/A	Curb Slope (%)	8.0

Possible Solutions:

Remove & Replace Curb Ramp With Two New Directional Ramps or Equivalent.

R304.3.2
