Access Compliance Report

Public Rights-of-Way

(Curb Ramps)

Intersection ID: 13404	Main Street: LEXINGTON_AV	Cross Street: E_CARSON_BV	Location: NW
ADA ID: 34BB0CA345E9	Ramp Type: Perp	Initial Pass/Fail: Fail	Overall Compliance: No
			Severity Score: 21.25

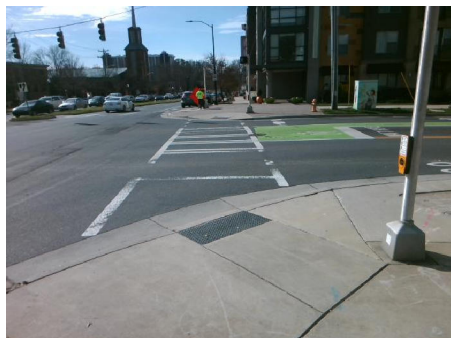
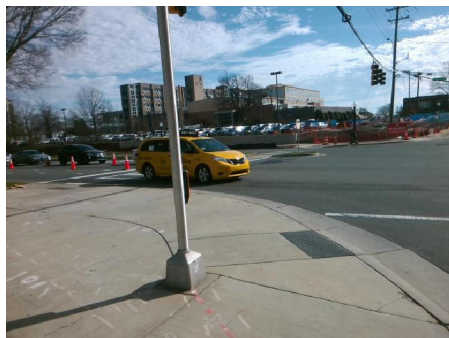
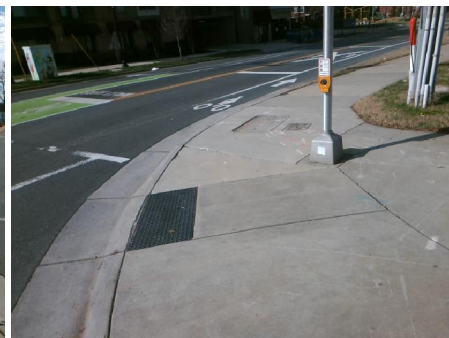
Not Found, R304.5.1, R304.2.2

Compliance	Description	Data	Compliance	Description	Data
N/A	Ramp Length (in)	94.0	No	Ramp Slope (%)	10.2
No	Ramp Width (in)	45.0	Yes	Ramp XSlope (%)	1.4
N/A	Flare Type LT	N/A	N/A	Flare Type RT	N/A
N/A	Flare Slope LT (%)	N/A	N/A	Flare Slope RT (%)	N/A
N/A	Flare Traversable LT?	N/A	N/A	Flare Traversable RT?	N/A
N/A	Landing Length (in)	N/A	N/A	DWS Provided?	N/A
N/A	Landing Width (in)	N/A	N/A	DWS Contrast?	N/A
N/A	Landing Slope (%)	N/A	N/A	DWS Length (in)	N/A
N/A	Landing X Slope (%)	N/A	N/A	DWS Full Width?	N/A
N/A	Landing Curb? (Y/N)	N/A	N/A	DWS Offset (in)	N/A
N/A	Shared Landing?	N/A			
N/A	Gutter Ponding?	N/A	N/A	Gutter Slope (%)	N/A
N/A	Gutter Lip Ht (in)	N/A	N/A	Gutter X Slope (%)	N/A
N/A	Painted X Walk1?	Yes	N/A	Painted X Walk2?	N/A
	X Walk 1 Direction	To SW		X Walk 2 Direction	N/A
N/A	X Walk 1 Width (in)	114.0	N/A	X Walk 2 Width (in)	N/A
	X Walk 1 Slope (%)	0.2		X Walk 2 Slope (%)	N/A
	X Walk 1 X Slope (%)	1.4		X Walk 2 X Slope (%)	N/A

N/A	Ramp inside XWalk1?	Yes	N/A	Ramp inside XWalk2?	N/A
	Road Slope (%)	N/A	N/A	Clear Space?	N/A
	Road X Slope (%)	N/A	N/A	Clear Space to XWalk (in)	N/A
N/A	Any Obstructions?	N/A	N/A	Storm Grate/Utility Hazard?	N/A
	Obstruction Type			Storm Grate/Utility Type	
		N/A			N/A
			Yes	Surface Condition? (G/P)	Good

Remove & Replace Entire Ramp.

Total Cost: \$ **1850.00**
