# Access Compliance Report

## Public Rights-of-Way

### (Curb Ramps)

| Intersection ID: 17241 | Main Street: S_CANTERBURY_RD | Cross Street: S_WENDOVER_RD | Location: NW |

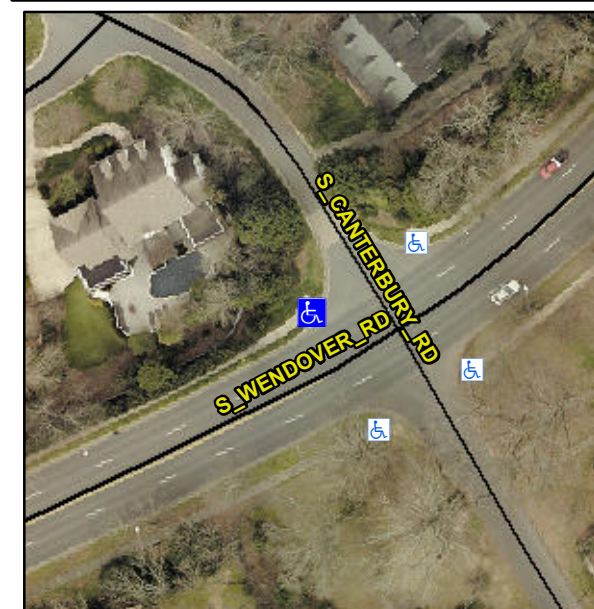
| ADA ID: 34BFFF82B90E | Ramp Type: PerpDiag | Initial Pass/Fail: Fail | Overall Compliance: No |
| Severity Score: 46.25 | | | |

**R304.5.1, R304.2.2, R304.5.3**

| Compliance | Description | Data | Compliance | Description | Data |
|---|---|---|---|---|---|
| N/A | Ramp Length (in) | 108.0 | No | Ramp Slope (%) | 12.7 |
| No | Ramp Width (in) | 47.0 | No | Ramp XSlope (%) | 6.0 |

**Remove & Replace Curb Ramp With Two New Directional Ramps or Equivalent.**

Total Cost: \$ 3200.00
