Access Compliance Report

Public Rights-of-Way

(Curb Ramps)

Intersection ID: 4049		Main Street: BICKHAM_LN		Cross Street: BROWNE'S_FERRY_RD		Location: NE											
ADA ID: 34C1BB11AB22		Ramp Type: Directional1		Initial Pass/Fail: Fail		Overall Compliance: No		Severity Score: 33.75									
Codes/Mitigation Info/Possible Solution				Field Measurements/Component Compliance													
<div>

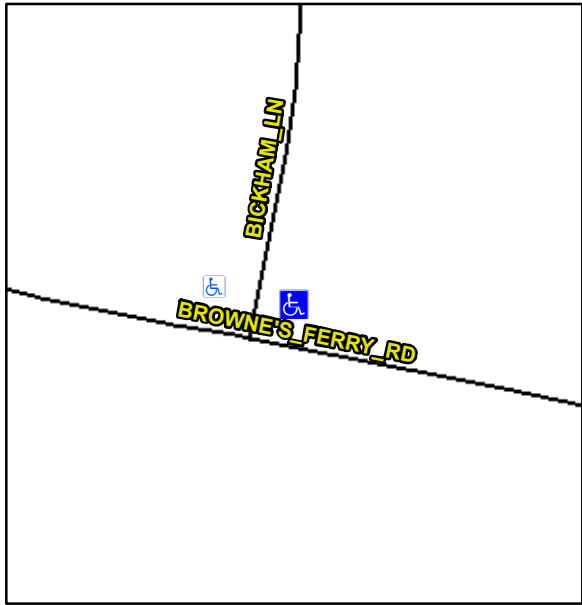
</div> <div>Street 1 NameBICKHAM_LN</div> <div>Stop Condition-Street 1StopSign</div> <div>Street 2 NameN/A</div> <div>Stop Condition-Street 2N/A</div>				Possible Solutions:		Compliance		Description		Data		Compliance		Description		Data	
				Remove & Replace Entire Ramp.		N/A		Ramp Length (in)		47.0		N/A		Grade Break?		N/A	
				Surveyor Notes: N/A		No		Ramp Width (in)		47.0		N/A		Grade Break Slope (%)		0.0	
						Yes		Ramp Slope (%)		6.4		N/A		Grade Break XSlope (%)		0.0	
						No		Ramp XSlope (%)		7.2							
						N/A		Flare Type LT		N/A		N/A		Flare Type RT		N/A	
						N/A		Flare Slope LT (%)		N/A		N/A		Flare Slope RT (%)		0.0

N/A		Flare Traversable LT?		N/A		N/A		Flare Traversable RT?		N/A	
						N/A		Landing Length (in)		0.0		N/A		DWS Provided?		N/A	
						N/A		Landing Width (in)		0.0		N/A		DWS Contrast?		N/A	
						N/A		Landing Slope (%)		0.0		N/A		DWS Length (in)		N/A	
						N/A		Landing X Slope (%)		0.0		N/A		DWS Full Width?		N/A	
				PROW/ADA: R304.5.1, R304.5.3		N/A		Landing Curb? (Y/N)		N/A		N/A		DWS Offset LT (in)		N/A	
						N/A		Shared Landing?		N/A		N/A		DWS Offset RT (in)		N/A	
						N/A		Gutter Ponding?		0.0		N/A		Gutter Slope (%)		N/A	
						N/A		Gutter Lip Ht (in)		0.0		N/A		Gutter X Slope (%)		N/A	
						N/A		Painted X Walk1?		No				Road Slope (%)		6.6	
								X Walk 1 Direction		To W				Road X Slope (%)		1.9	
								X Walk 1 Width (in)		N/A				Clear Space?		N/A	
								X Walk 1 Slope (%)		6.6		N/A		Clear Space to XWalk (in)		N/A	
								X Walk 1 X Slope (%)		1.9		N/A		Storm Grate/Utility Hazard?		N/A

N/A		Ramp inside XWalk1?		N/A				Storm Grate/Utility Type			
				Total Cost: \$ 1600.00		N/A		Any Obstructions?		N/A						N/A	
								Obstruction Type				Yes		Surface Condition? (G/P)		Good	
										N/A		N/A		Curb Slope (%)		8.4
