Access Compliance Report

Public Rights-of-Way

(Curb Ramps)

Intersection ID: 11208	Main Street: PARKWOOD_AV	Cross Street: N_BREVARD_ST	Location: NW
ADA ID: 34C30C6BB5F6	Ramp Type: Perp	Initial Pass/Fail: Fail	Overall Compliance: No
			Severity Score: 21.25

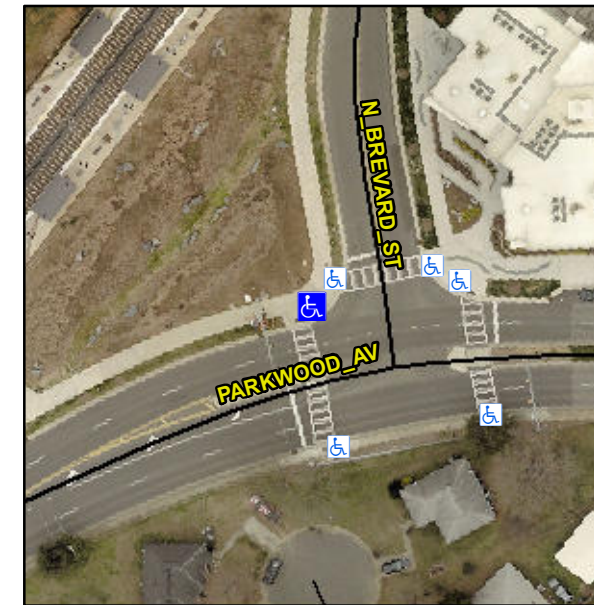
Not Found, R304.5.1, R304.2.2

Compliance	Description	Data	Compliance	Description	Data
N/A	Ramp Length (in)	72.0	No	Ramp Slope (%)	9.2
No	Ramp Width (in)	45.0	Yes	Ramp XSlope (%)	0.4
N/A	Flare Type LT	N/A	N/A	Flare Type RT	N/A
N/A	Flare Slope LT (%)	N/A	N/A	Flare Slope RT (%)	N/A
N/A	Flare Traversable LT?	N/A	N/A	Flare Traversable RT?	N/A
N/A	Landing Length (in)	N/A	N/A	DWS Provided?	N/A
N/A	Landing Width (in)	N/A	N/A	DWS Contrast?	N/A
N/A	Landing Slope (%)	N/A	N/A	DWS Length (in)	N/A
N/A	Landing X Slope (%)	N/A	N/A	DWS Full Width?	N/A
N/A	Landing Curb? (Y/N)	N/A	N/A	DWS Offset (in)	N/A
N/A	Shared Landing?	N/A			
N/A	Gutter Ponding?	N/A	N/A	Gutter Slope (%)	N/A
N/A	Gutter Lip Ht (in)	N/A	N/A	Gutter X Slope (%)	N/A
N/A	Painted X Walk1?	Yes	N/A	Painted X Walk2?	N/A
	X Walk 1 Direction	To S		X Walk 2 Direction	N/A
N/A	X Walk 1 Width (in)	113.0	N/A	X Walk 2 Width (in)	N/A
	X Walk 1 Slope (%)	4.3		X Walk 2 Slope (%)	N/A
	X Walk 1 X Slope (%)	0.8		X Walk 2 X Slope (%)	N/A

N/A	Ramp inside XWalk1?	Yes	N/A	Ramp inside XWalk2?	N/A
	Road Slope (%)	N/A	N/A	Clear Space?	N/A
	Road X Slope (%)	N/A	N/A	Clear Space to XWalk (in)	N/A
N/A	Any Obstructions?	N/A	N/A	Storm Grate/Utility Hazard?	N/A
	Obstruction Type			Storm Grate/Utility Type	
		N/A			N/A
			Yes	Surface Condition? (G/P)	Good

Remove & Replace Entire Ramp.

Total Cost: \$ 1850.00
