# Access Compliance Report

## Public Rights-of-Way (Curb Ramps)

| Intersection ID: N/A | Main Street: ELEVATION_POINT_DR | Cross Street: FLOURNOY_DR | Location: N |
| ADA ID: 34CFE258CA06 | Ramp Type: Directional1 | Initial Pass/Fail: Pass | Overall Compliance: No |

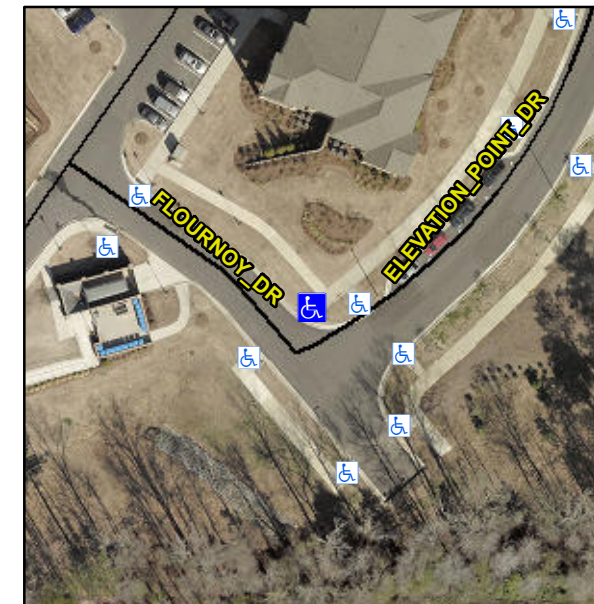
| Severity Score: 0.25 | | | |

**Not Found, R304.5.2, R304.5.3**

**Remove & Replace Entire Ramp.  
Remove & Replace Gutter.**

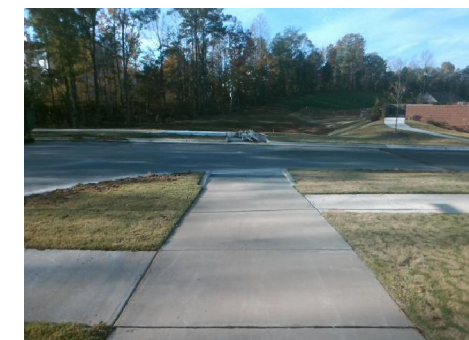
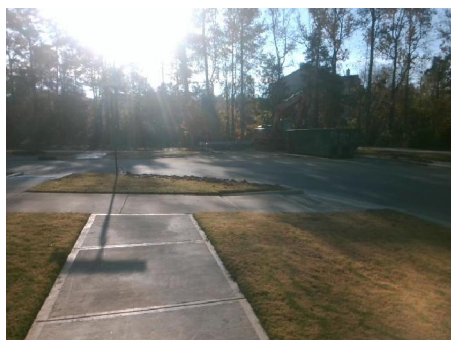
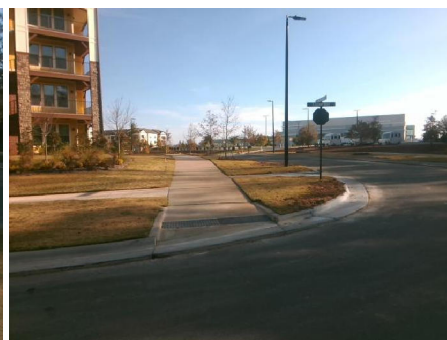
| Compliance | Description | Data | Compliance | Description | Data |
|---|---|---|---|---|---|
| N/A | Ramp Length (in) | 278.0 | No | Grade Break? | No |
| Yes | Gutter Lip Ht (in) | 0.0 | No | Gutter X Slope (%) | 4.7 |
