Access Compliance Report

Public Rights-of-Way

(Curb Ramps)

Intersection ID: 10040845	Main Street: WAKEFIELD_DR	Cross Street: N/A	Location: S
ADA ID: 34DC5F283878	Ramp Type: Directional	Initial Pass/Fail: Fail	Overall Compliance: No
Severity Score: 12.5			
Codes/Mitigation Info/Possible Solution		Field Measurements/Component Compliance

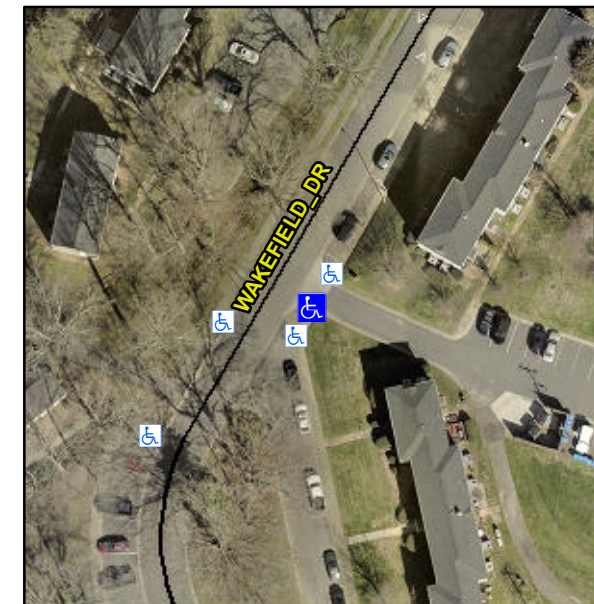
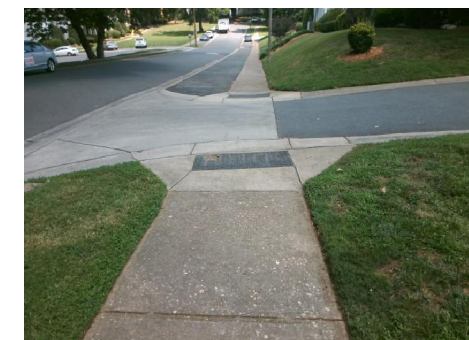
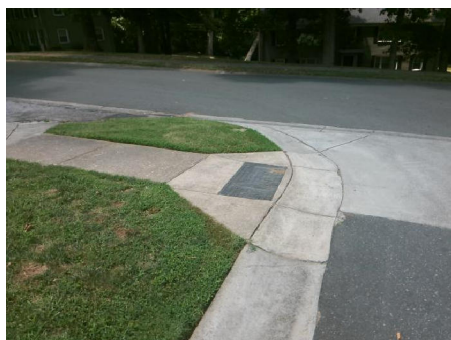
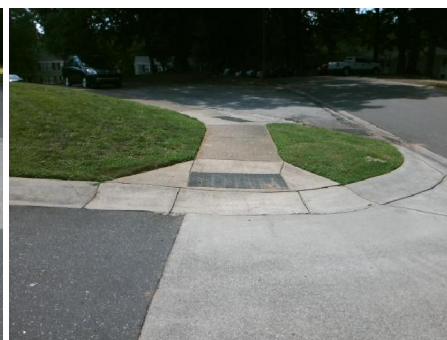
DAMAGED DWS

R304.5.3

Compliance	Description	Data	Compliance	Description	Data
N/A	Ramp Length (in)	54.0	N/A	Grade Break?	N/A
Yes	Ramp Width (in)	48.0	N/A	Grade Break Slope (%)	0.0
Yes	Ramp Slope (%)	5.2	N/A	Grade Break XSlope (%)	0.0
No	Ramp XSlope (%)	6.5			
N/A	Flare Type LT	N/A	N/A	Flare Type RT	N/A
N/A	Flare Slope LT (%)	N/A	N/A	Flare Slope RT (%)	0.0
N/A	Flare Traversable LT?	N/A	N/A	Flare Traversable RT?	N/A
N/A	Landing Length (in)	0.0	N/A	DWS Provided?	N/A
N/A	Landing Width (in)	0.0	N/A	DWS Contrast?	N/A
N/A	Landing Slope (%)	0.0	N/A	DWS Length (in)	N/A
N/A	Landing X Slope (%)	0.0	N/A	DWS Full Width?	N/A
N/A	Landing Curb? (Y/N)	N/A	N/A	DWS Offset LT (in)	N/A
N/A	Shared Landing?	N/A	N/A	DWS Offset RT (in)	N/A
N/A	Gutter Ponding?	0.0	N/A	Gutter Slope (%)	N/A
N/A	Gutter Lip Ht (in)	0.0	N/A	Gutter X Slope (%)	N/A
N/A	Painted X Walk1?	No		Road Slope (%)	2.3
	X Walk 1 Direction	To N		Road X Slope (%)	6.0
	X Walk 1 Width (in)	N/A		Clear Space?	N/A

X Walk 1 Slope (%)	2.3	N/A	Clear Space to XWalk (in)	N/A
	X Walk 1 X Slope (%)	6.0	N/A	Storm Grate/Utility Hazard?	N/A
N/A	Ramp inside XWalk1?	N/A		Storm Grate/Utility Type	
N/A	Any Obstructions?	N/A			N/A
	Obstruction Type		Yes	Surface Condition? (G/P)	Good
			N/A	Curb Slope (%)	11.4

Possible Solutions:

Remove & Replace Entire Ramp.
