# Access Compliance Report

## Public Rights-of-Way

### (Curb Ramps)

| Intersection ID: 3938 | Main Street: MOUNTAIN_PARK_DR | Cross Street: STONY_PATH_DR | Location: SW |

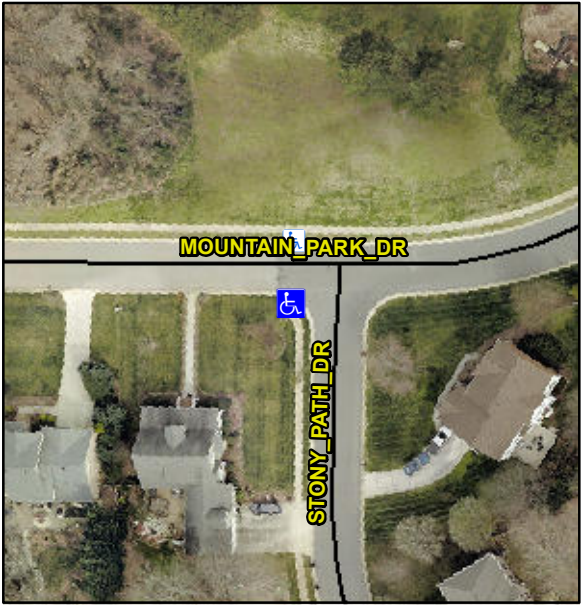
| ADA ID: 34DFDDB2A17F | Ramp Type: Perp | Initial Pass/Fail: Fail | Overall Compliance: No |

| Codes/Mitigation Info/Possible Solution | | | Field Measurements/Component Compliance | | |
|---|---|--|---|---|---|
| | <b>Remove &amp; Replace Entire Ramp.</b> | | <b>No</b> | Ramp Length (in) | <b>51.0</b> |
| <p>Surveyor Notes:</p> <p><b>N/A</b></p> <p>PROW/ADA:</p> <p><b>Not Found, R304.2.2, R304.5.3</b></p> | | | <b>N/A</b> | Flare Type RT | <b>N/A</b> |

| Codes/Mitigation Info/Possible Solution | | | Field Measurements/Component Compliance | | |
|---|---|--|---|---|---|
| | Possible Solutions: | | <b>Compliance</b> | <b>Description</b> | <b>Data</b> |
| Total Cost: \$ 1850.00 | | | <b>N/A</b> | Storm Grate/Utility Hazard? | <b>N/A</b> |
