Access Compliance Report

Public Rights-of-Way

(Curb Ramps)

Intersection ID: N/A	Main Street: VILLAGE_WALK_RD	Cross Street: HOUSTON_FIELD_CT	Location: NW
ADA ID: 34EB52FAACB8	Ramp Type: Perp	Initial Pass/Fail: Fail	Overall Compliance: No
			Severity Score: 21.25

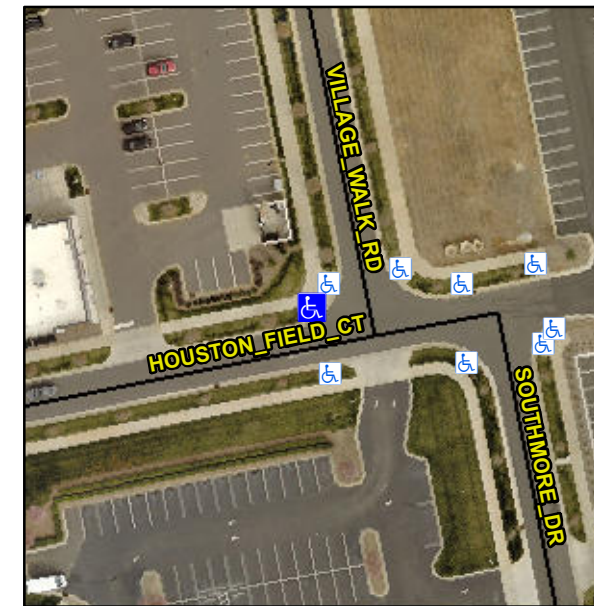
Not Found, R304.5.1, R304.5.3

Compliance	Description	Data	Compliance	Description	Data
N/A	Ramp Length (in)	95.0	Yes	Ramp Slope (%)	6.8
No	Ramp Width (in)	38.0	No	Ramp XSlope (%)	5.5
N/A	Flare Type LT	N/A	N/A	Flare Type RT	N/A
N/A	Flare Slope LT (%)	N/A	N/A	Flare Slope RT (%)	N/A
N/A	Flare Traversable LT?	N/A	N/A	Flare Traversable RT?	N/A
N/A	Landing Length (in)	N/A	N/A	DWS Provided?	N/A
N/A	Landing Width (in)	N/A	N/A	DWS Contrast?	N/A
N/A	Landing Slope (%)	N/A	N/A	DWS Length (in)	N/A
N/A	Landing X Slope (%)	N/A	N/A	DWS Full Width?	N/A
N/A	Landing Curb? (Y/N)	N/A	N/A	DWS Offset (in)	N/A
N/A	Shared Landing?	N/A			
N/A	Gutter Ponding?	N/A	N/A	Gutter Slope (%)	N/A
N/A	Gutter Lip Ht (in)	N/A	N/A	Gutter X Slope (%)	N/A
N/A	Painted X Walk1?	No	N/A	Painted X Walk2?	N/A
	X Walk 1 Direction	To S		X Walk 2 Direction	N/A
N/A	X Walk 1 Width (in)	N/A	N/A	X Walk 2 Width (in)	N/A
	X Walk 1 Slope (%)	1.5		X Walk 2 Slope (%)	N/A
	X Walk 1 X Slope (%)	5.6		X Walk 2 X Slope (%)	N/A

N/A	Ramp inside XWalk1?	N/A	N/A	Ramp inside XWalk2?	N/A
	Road Slope (%)	N/A	N/A	Clear Space?	N/A
	Road X Slope (%)	N/A	N/A	Clear Space to XWalk (in)	N/A
N/A	Any Obstructions?	N/A	N/A	Storm Grate/Utility Hazard?	N/A
	Obstruction Type			Storm Grate/Utility Type	
		N/A			N/A
			Yes	Surface Condition? (G/P)	Good

Remove & Replace Entire Ramp.
