Access Compliance Report Public Rights-of-Way (Curb Ramps)

Intersection ID: 10036588Main Street: RUNNYMEDE_LNCross Street: N/ALocation:NWADA ID: 34EEDEE2C36ARamp Type: PerpInitial Pass/Fail: FailOverall Compliance: NoSeverity Score: 13.75

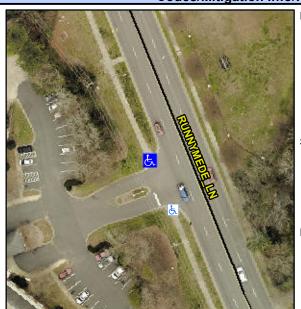
Field Measurements/Component Compliance							
Compliance Description		Data	Comp	oliance Description	Data		
N/	A Ramp Length (in)	72.0	No	Ramp Slope (%)	8.8		
Ye	s Ramp Width (in)	48.0	No	Ramp XSlope (%)	4.4		
N/	A Flare Type LT	N/A	N/A	Flare Type RT	N/A		
N/	A Flare Slope LT (%)	N/A	N/A	Flare Slope RT (%)	N/A		
N/	A Flare Traversable LT?	N/A	N/A	Flare Traversable RT?	N/A		
N/	A Landing Length (in)	N/A	N/A	DWS Provided?	N/A		
N/	A Landing Width (in)	N/A	N/A	DWS Contrast?	N/A		
N/	A Landing Slope (%)	N/A	N/A	DWS Length (in)	N/A		
N/	A Landing X Slope (%)	N/A	N/A	DWS Full Width?	N/A		
N/	A Landing Curb? (Y/N)	N/A	N/A	DWS Offset (in)	N/A		
N/	A Shared Landing?	N/A					
N/	A Gutter Ponding?	N/A	N/A	Gutter Slope (%)	N/A		
N/	A Gutter Lip Ht (in)	N/A	N/A	Gutter X Slope (%)	N/A		
N/	A Painted X Walk1?	No	N/A	Painted X Walk2?	N/A		
	X Walk 1 Direction	To S		X Walk 2 Direction	N/A		
N/	A X Walk 1 Width (in)	N/A	N/A	X Walk 2 Width (in)	N/A

X Walk 1 Slope (%)	2.6		X Walk 2 Slope (%)	N/A		
	X Walk 1 X Slope (%)	4.3		X Walk 2 X Slope (%)	N/A		
N/	A Ramp inside XWalk1?	N/A	N/A	Ramp inside XWalk2?	N/A		
	Road Slope (%)	N/A	N/A	Clear Space?	N/A		
	Road X Slope (%)	N/A	N/A	Clear Space to XWalk (in)	N/A		
N/	A Any Obstructions?	N/A	N/A	Storm Grate/Utility Hazard?	N/A		
	Obstruction Type			Storm Grate/Utility Type			
		N/A			N/A		
Alter Visio			Yes	Surface Condition? (G/P)	Good

Possible Solutions:					
Remove & Replace Entire Ramp.					
	•				
	I				
Surveyor Notes:					
N/A					
N/A					
PROW/ADA:	ı				
Not Found, R304.2.2, R304.5.3	ı				
	ı				
	ı
