## **Access Compliance Report Public Rights-of-Way** (Curb Ramps)

Intersection ID: 29604 Main Street: CAMDEN CREEK LN **Cross Street: SANDY PORTER RD** Location: Ramp Type: PerpDiag Initial Pass/Fail: Fail **Overall Compliance: No** Severity Score: 21.25 ADA ID: 34F16705E779

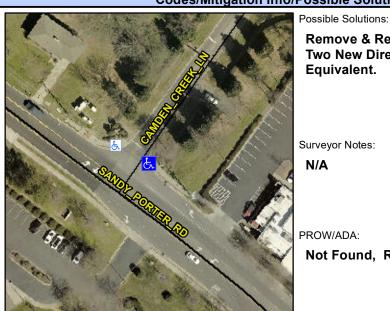
Not Found, R304.5.1, R304.2.2

Comp	liance Description	Data	Comp	liance	Description	Data
N/A	Ramp Length (in)	70.0	No	Ramp	Slope (%)	10.3
No	Ramp Width (in)	41.0	Yes	Ramp	XSlope (%)	1.7
N/A	Flare Type LT	N/A	N/A	Flare	Type RT	N/A
N/A	Flare Slope LT (%)	N/A	N/A	Flare	Slope RT (%)	N/A
N/A	Flare Traversable LT?	N/A	N/A	Flare	Traversable RT?	N/A
N/A	Landing Length (in)	N/A	N/A	DWS	Provided?	N/A
N/A	Landing Width (in)	N/A	N/A	DWS	Contrast?	N/A
N/A	Landing Slope (%)	N/A	N/A	DWS	Length (in)	N/A
N/A	Landing X Slope (%)	N/A	N/A	DWS	Full Width?	N/A
N/A	Landing Curb? (Y/N)	N/A	N/A	DWS	Offset (in)	N/A
N/A	Shared Landing?	N/A				
N/A	Gutter Ponding?	N/A	N/A	Gutte	r Slope (%)	N/A
N/A	Gutter Lip Ht (in)	N/A	N/A	Gutte	r X Slope (%)	N/A
N/A	Painted X Walk1?	No	N/A	Paint	ed X Walk2?	No
	X Walk 1 Direction	To NW		X Wa	lk 2 Direction	To SW
N/A	X Walk 1 Width (in)	N/A	N/A	X Wa	lk 2 Width (in)	N/A
	X Walk 1 Slope (%)	1.9		X Wa	lk 2 Slope (%)	0.5
	X Walk 1 X Slope (%)	0.1		X Wa	lk 2 X Slope (%)	2.0

Street 1 Name Stop Condition-Street 2 Street 2 Name Stop Condition-Street 1 **CAMDEN CREEK LN** StopSign **SANDY PORTER RD**  Remove & Replace Curb Ramp With Two New Directional Ramps or Equivalent.
