Access Compliance Report

Public Rights-of-Way

(Curb Ramps)

Intersection ID: 13559	Main Street: W_WORTHINGTON_AV	Cross Street: WEST_BV	Location: N
ADA ID: 34FA2647CF35	Ramp Type: ParaDiag	Initial Pass/Fail: Fail	Overall Compliance: No
Codes/Mitigation Info/Possible Solution		Field Measurements/Component Compliance

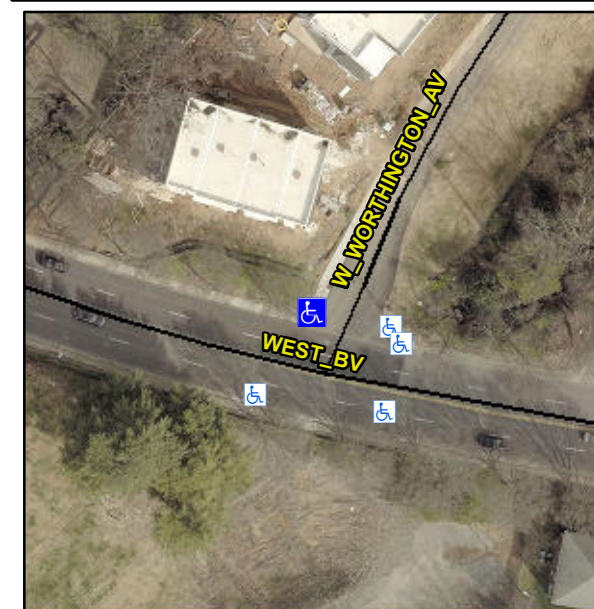
Compliance	Description	Data	Compliance	Description	Data
N/A	Ramp Length LT (in)	56.0	N/A	Ramp Length RT (in)	60.0
Yes	Ramp Width LT (in)	48.0	Yes	Ramp Width RT (in)	48.0
Yes	Ramp Slope LT (%)	6.8	No	Ramp Slope RT (%)	19.9
No	Ramp XSlope LT (%)	2.3	No	Ramp XSlope RT (%)	2.9
N/A	Landing Length (in)	N/A	N/A	DWS Provided?	N/A
N/A	Landing Width (in)	N/A	N/A	DWS Contrast?	N/A
N/A	Landing Slope (%)	N/A	N/A	DWS Length (in)	N/A
N/A	Landing X Slope (%)	N/A	N/A	DWS Full Width?	N/A
N/A	Landing Curb? (Y/N)	N/A	N/A	DWS Offset (in)	N/A
N/A	Shared Landing?	N/A			
N/A	Gutter Ponding?	N/A	N/A	Gutter Slope (%)	N/A
N/A	Gutter Lip Ht (in)	N/A	N/A	Gutter X Slope (%)	N/A
N/A	Painted X Walk1?	No	N/A	Painted X Walk2?	No
	X Walk 1 Direction	To SW		X Walk 2 Direction	To SE
N/A	X Walk 1 Width (in)	N/A	N/A	X Walk 2 Width (in)	N/A
	X Walk 1 Slope (%)	9.2		X Walk 2 Slope (%)	2.2
	X Walk 1 X Slope (%)	3.2		X Walk 2 X Slope (%)	9.3
N/A	Ramp inside XWalk1?	N/A	N/A	Ramp inside XWalk2?	N/A

Road Slope (%)	10.6	N/A	Clear Space?	N/A
	Road X Slope (%)	4.0	N/A	Clear Space to XWalk (in)	N/A
N/A	Any Obstructions?	N/A	N/A	Storm Grate/Utility Hazard?	N/A
	Obstruction Type			Storm Grate/Utility Type	
		N/A			N/A
			Yes	Surface Condition? (G/P)	Good
			N/A	Curb Slope (%)	22.2

Possible Solutions:

Remove & Replace Curb Ramp With Two New Directional Ramps or Equivalent.
