Access Compliance Report

Public Rights-of-Way

(Curb Ramps)

Intersection ID: 54318	Main Street: CANTERBURY_CASTLE_DR	Cross Street: BELMONT_MANSION_DR	Location: NE
ADA ID: 34FF6701A4FB	Ramp Type: BlendTrans1	Initial Pass/Fail: Fail	Overall Compliance: No
		Severity Score: 8.75

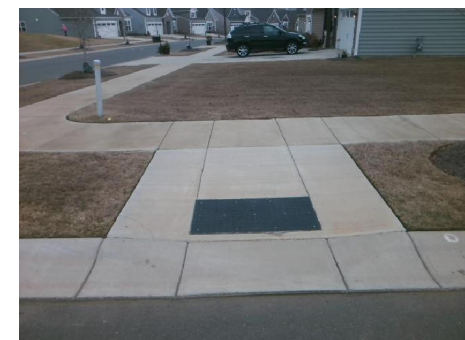
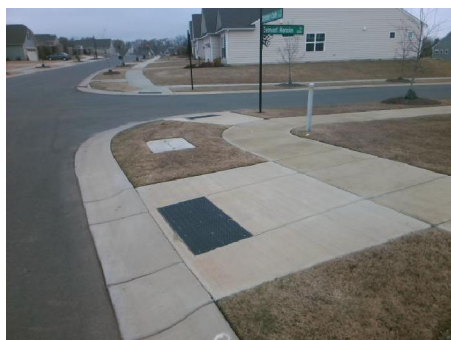
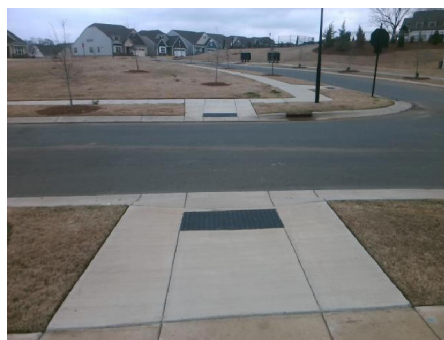
Compliance	Description	Data	Compliance	Description	Data
N/A	Ramp Length (in)	86.0	Yes	BlendTrans Slope (%)	3.9
No	Ramp Width (in)	45.0	Yes	BlendTrans XSlope (%)	0.8
N/A	Flare Type LT	N/A	N/A	Flare Type RT	N/A
N/A	Flare Slope LT (%)	N/A	N/A	Flare Slope RT (%)	N/A
N/A	Flare Traversable LT?	N/A	N/A	Flare Traversable RT?	N/A
N/A	Landing Length (in)	N/A	N/A	DWS Provided?	N/A
N/A	Landing Width (in)	N/A	N/A	DWS Contrast?	N/A
N/A	Landing Slope (%)	N/A	N/A	DWS Length (in)	N/A
N/A	Landing X Slope (%)	N/A	N/A	DWS Full Width?	N/A
N/A	Landing Curb? (Y/N)	N/A	N/A	DWS Offset (in)	N/A
N/A	Shared Landing?	N/A			
N/A	Gutter Ponding?	N/A	N/A	Gutter Slope (%)	N/A
N/A	Gutter Lip Ht (in)	1.0	N/A	Gutter X Slope (%)	N/A
N/A	Painted X Walk1?	No	N/A	Painted X Walk2?	N/A
	X Walk 1 Direction	To S		X Walk 2 Direction	N/A
	X Walk 1 Width (in)	N/A		X Walk 2 Width (in)	N/A
	X Walk 1 Slope (%)	2.7		X Walk 2 Slope (%)	N/A
	X Walk 1 X Slope (%)	0.5		X Walk 2 X Slope (%)	N/A

N/A	Ramp inside XWalk1?	N/A	N/A	Ramp inside XWalk2?	N/A
	Road Slope (%)	0.5		Clear Space?	N/A
	Road X Slope (%)	2.7	N/A	Clear Space to XWalk (in)	N/A
N/A	Any Obstructions?	N/A	N/A	Storm Grate/Utility Hazard?	N/A
	Obstruction Type			Storm Grate/Utility Type	
		N/A			N/A
			Yes	Surface Condition? (G/P)	Good
			N/A	Curb Slope (%)	3.5

Remove & Replace Curb Ramp With Two New Directional Ramps or Equivalent.
