Access Compliance Report

Public Rights-of-Way

(Curb Ramps)

Intersection ID: 14064	Main Street: E_PARK_AV	Cross Street: EUCLID_AV	Location: E
ADA ID: 351458BCA2E3	Ramp Type: PerpDiag	Initial Pass/Fail: Fail	Overall Compliance: No
Severity Score: 12.5			
Codes/Mitigation Info/Possible Solution		Field Measurements/Component Compliance

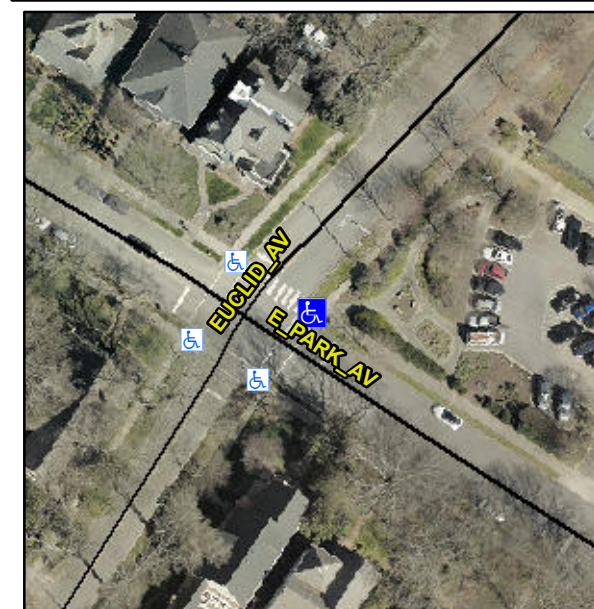
Not Found, R304.2.2

Compliance	Description	Data	Compliance	Description	Data
N/A	Ramp Length (in)	45.0	No	Ramp Slope (%)	9.9
Yes	Ramp Width (in)	48.0	Yes	Ramp XSlope (%)	0.5
N/A	Flare Type LT	N/A	N/A	Flare Type RT	N/A
N/A	Flare Slope LT (%)	N/A	N/A	Flare Slope RT (%)	N/A
N/A	Flare Traversable LT?	N/A	N/A	Flare Traversable RT?	N/A
N/A	Landing Length (in)	N/A	N/A	DWS Provided?	N/A
N/A	Landing Width (in)	N/A	N/A	DWS Contrast?	N/A
N/A	Landing Slope (%)	N/A	N/A	DWS Length (in)	N/A
N/A	Landing X Slope (%)	N/A	N/A	DWS Full Width?	N/A
N/A	Landing Curb? (Y/N)	N/A	N/A	DWS Offset (in)	N/A
N/A	Shared Landing?	N/A			
N/A	Gutter Ponding?	N/A	N/A	Gutter Slope (%)	N/A
N/A	Gutter Lip Ht (in)	N/A	N/A	Gutter X Slope (%)	N/A
N/A	Painted X Walk1?	Yes	N/A	Painted X Walk2?	Yes
	X Walk 1 Direction	To NW		X Walk 2 Direction	To SW
N/A	X Walk 1 Width (in)	117.0	N/A	X Walk 2 Width (in)	102.0
	X Walk 1 Slope (%)	4.1		X Walk 2 Slope (%)	6.3
	X Walk 1 X Slope (%)	4.7		X Walk 2 X Slope (%)	3.0

N/A	Ramp inside XWalk1?	Yes	N/A	Ramp inside XWalk2?	Yes
	Road Slope (%)	0.8	N/A	Clear Space?	N/A
	Road X Slope (%)	6.9	N/A	Clear Space to XWalk (in)	N/A
N/A	Any Obstructions?	N/A	N/A	Storm Grate/Utility Hazard?	N/A
	Obstruction Type			Storm Grate/Utility Type	
		N/A			N/A
		Yes		Surface Condition? (G/P)	Good

Remove & Replace Curb Ramp With Two New Directional Ramps or Equivalent.
