Access Compliance Report Public Rights-of-Way (Curb Ramps)

Intersection ID: 25446 Main Street: ARCHGATE_CT Cross Street: SOUTHBRIDGE_FOREST_DR Location: NE

ADA ID: 3514700C4E9C Ramp Type: PerpDiag Initial Pass/Fail: Fail Overall Compliance: No Severity Score: 13.75

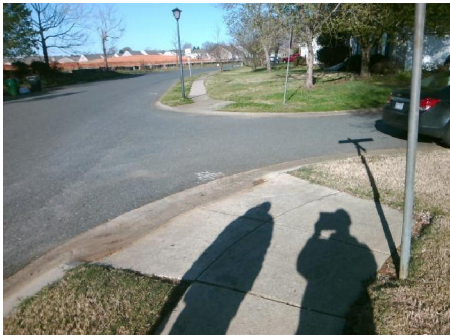
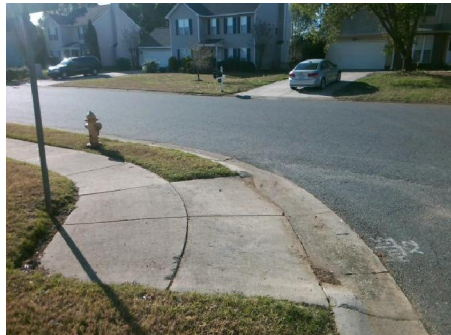
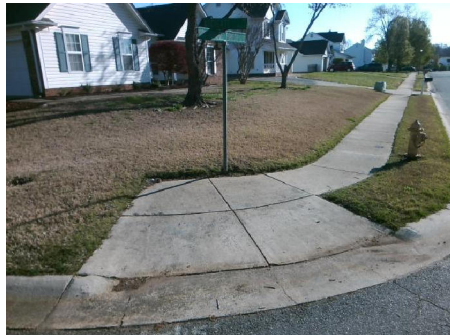
PROW/ADA:
R304.2.2, R304.5.3

Compliance	Description	Data	Compliance	Description	Data
N/A	Ramp Length (in)	46.5	No	Ramp Slope (%)	10.2
Yes	Ramp Width (in)	48.0	No	Ramp XSlope (%)	2.2
N/A	Flare Type LT	N/A	N/A	Flare Type RT	N/A
N/A	Flare Slope LT (%)	N/A	N/A	Flare Slope RT (%)	N/A
N/A	Flare Traversable LT?	N/A	N/A	Flare Traversable RT?	N/A
N/A	Landing Length (in)	N/A	N/A	DWS Provided?	N/A
N/A	Landing Width (in)	N/A	N/A	DWS Contrast?	N/A
N/A	Landing Slope (%)	N/A	N/A	DWS Length (in)	N/A
N/A	Landing X Slope (%)	N/A	N/A	DWS Full Width?	N/A
N/A	Landing Curb? (Y/N)	N/A	N/A	DWS Offset (in)	N/A
N/A	Shared Landing?	N/A			
N/A	Gutter Ponding?	N/A	N/A	Gutter Slope (%)	N/A
N/A	Gutter Lip Ht (in)	N/A	N/A	Gutter X Slope (%)	N/A
N/A	Painted X Walk1?	No	N/A	Painted X Walk2?	No
	X Walk 1 Direction	To W		X Walk 2 Direction	To S
N/A	X Walk 1 Width (in)	N/A	N/A	X Walk 2 Width (in)	N/A
	X Walk 1 Slope (%)	0.4		X Walk 2 Slope (%)	2.5
	X Walk 1 X Slope (%)	1.6		X Walk 2 X Slope (%)	3.4

N/A	Ramp inside XWalk1?	N/A	N/A	Ramp inside XWalk2?	N/A
	Road Slope (%)	2.7	N/A	Clear Space?	N/A
	Road X Slope (%)	5.1	N/A	Clear Space to XWalk (in)	N/A
N/A	Any Obstructions?	N/A	N/A	Storm Grate/Utility Hazard?	N/A
	Obstruction Type			Storm Grate/Utility Type	
		N/A			N/A
Yes	Surface Condition? (G/P)				Good

Possible Solutions:
Remove & Replace Curb Ramp With Two New Directional Ramps or Equivalent.
