Access Compliance Report Public Rights-of-Way (Curb Ramps)

Intersection ID: 53202 Main Street: FLINTROCK_RD Cross Street: LITTLE_ROCK_RD Location: N

ADA ID: 351A8B5E19A2 Ramp Type: Perp Initial Pass/Fail: Fail Overall Compliance: No Severity Score: 22.5

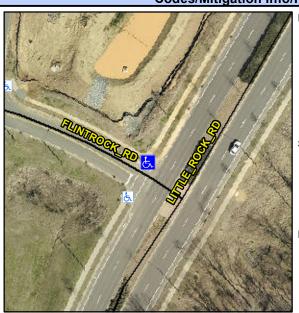
ľ	Possible Solutions:					
100	Remove & Replace Entire Ramp.					
Ź						
d						
CASTON DE	Surveyor Notes:					
	N/A					
N						
Š						
2						
	PROW/ADA:					
	Not Found, R304.5.1, R304.2.2,					
ŝ	R304.5.3					
N

Field Measurements/Component Compliance							
Comp	liance Description	Data	Comp	liance Description	Data		
N/A	N/A Ramp Length (in)		No	Ramp Slope (%)	9.6		
No	Ramp Width (in)	46.5	No	Ramp XSlope (%)	2.2		
N/A	Flare Type LT	N/A	N/A	Flare Type RT	N/A		
N/A	Flare Slope LT (%)	N/A	N/A	Flare Slope RT (%)	N/A		
N/A	Flare Traversable LT?	N/A	N/A	Flare Traversable RT?	N/A		
N/A	Landing Length (in)	N/A	N/A	DWS Provided?	N/A		
N/A	Landing Width (in)	N/A	N/A	DWS Contrast?	N/A		
N/A	Landing Slope (%)	N/A	N/A	DWS Length (in)	N/A		
N/A	Landing X Slope (%)	N/A	N/A	DWS Full Width?	N/A		
N/A	Landing Curb? (Y/N)	N/A	N/A	DWS Offset (in)	N/A		
N/A	Shared Landing?	N/A					
N/A	Gutter Ponding?	N/A	N/A	Gutter Slope (%)	N/A		
N/A	Gutter Lip Ht (in)	N/A	N/A	Gutter X Slope (%)	N/A		
N/A	Painted X Walk1?	Yes	N/A	Painted X Walk2?	N/A		
	X Walk 1 Direction	To SW		X Walk 2 Direction	N/A		
N/A	X Walk 1 Width (in)	96.0	N/A	X Walk 2 Width (in)	N/A
