# Access Compliance Report

## Public Rights-of-Way

| Intersection ID: 10668 | Main Street: LYME_BROOK_LN | Cross Street: SPRATT_ST | Location: | N |
| ADA ID: 351AC1C586BB | Ramp Type: PerpDiag | Initial Pass/Fail: Fail | Overall Compliance: No | Severity Score: 10 |

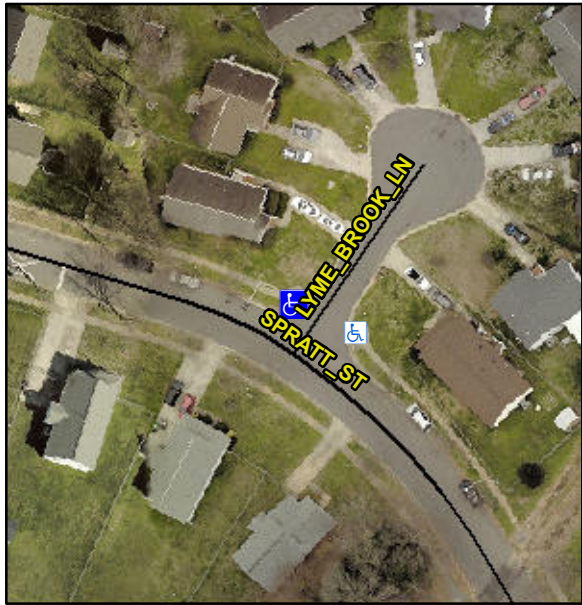
| Codes/Mitigation Info/Possible Solution | | | Field Measurements/Component Compliance | | | | | |
|---|---|---|---|---|---|---|---|---|
| | Remove & Replace Curb Ramp With Two New Directional Ramps or Equivalent. | | N/A | Ramp Length (in) | 60.0 | Yes | Ramp Slope (%) | 6.5 |
| | | | No | Ramp Width (in) | 36.5 | No | Ramp XSlope (%) | 3.9 |
| PROW/ADA: | | Not Found, R304.5.1, R304.5.3 | N/A | Shared Landing? | N/A | | | |
