Access Compliance Report

Public Rights-of-Way

(Curb Ramps)

Intersection ID: 53743	Main Street: SMITH_RD	Cross Street: CANTERBURY_CASTLE_DR	Location: SW
ADA ID: 351D4DEF16FA	Ramp Type: BlendTrans1	Initial Pass/Fail: Fail	Overall Compliance: No
		Severity Score: 25

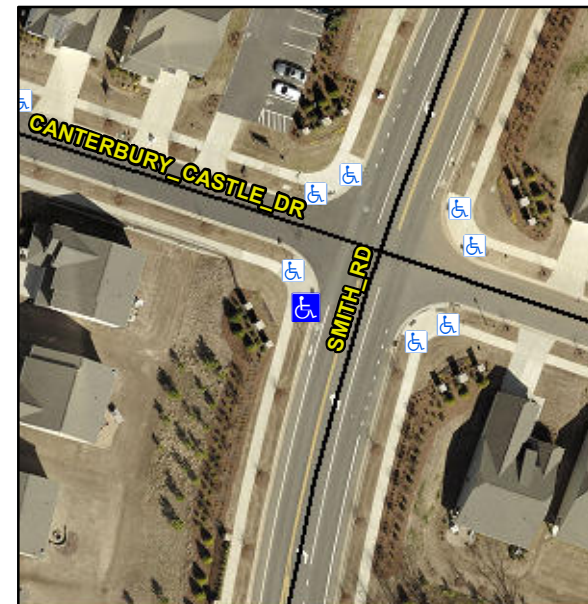
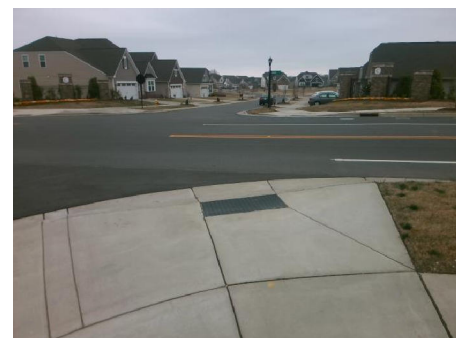
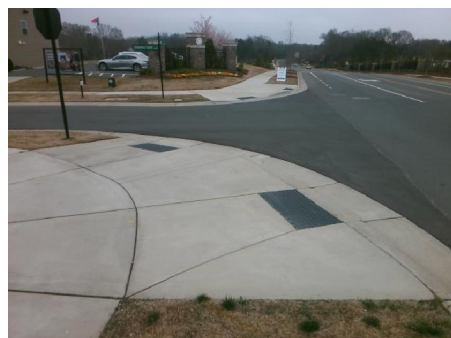
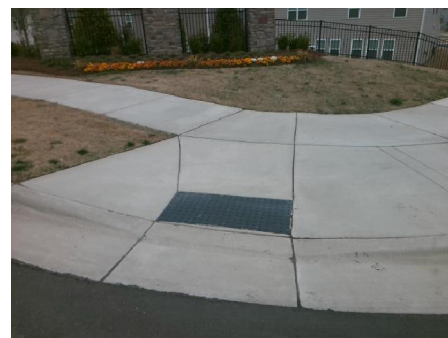
Compliance	Description	Data	Compliance	Description	Data
N/A	Ramp Length (in)	93.0	Yes	BlendTrans Slope (%)	0.9
Yes	Ramp Width (in)	48.0	No	BlendTrans XSlope (%)	8.6
N/A	Flare Type LT	N/A	N/A	Flare Type RT	N/A
N/A	Flare Slope LT (%)	N/A	N/A	Flare Slope RT (%)	N/A
N/A	Flare Traversable LT?	N/A	N/A	Flare Traversable RT?	N/A
N/A	Landing Length (in)	N/A	N/A	DWS Provided?	N/A
N/A	Landing Width (in)	N/A	N/A	DWS Contrast?	N/A
N/A	Landing Slope (%)	N/A	N/A	DWS Length (in)	N/A
N/A	Landing X Slope (%)	N/A	N/A	DWS Full Width?	N/A
N/A	Landing Curb? (Y/N)	N/A	N/A	DWS Offset (in)	N/A
N/A	Shared Landing?	N/A			
N/A	Gutter Ponding?	N/A	N/A	Gutter Slope (%)	N/A
N/A	Gutter Lip Ht (in)	N/A	N/A	Gutter X Slope (%)	N/A
N/A	Painted X Walk1?	No	N/A	Painted X Walk2?	N/A
	X Walk 1 Direction	To SE		X Walk 2 Direction	N/A
	X Walk 1 Width (in)	N/A		X Walk 2 Width (in)	N/A
	X Walk 1 Slope (%)	0.4		X Walk 2 Slope (%)	N/A
	X Walk 1 X Slope (%)	3.3		X Walk 2 X Slope (%)	N/A

N/A	Ramp inside XWalk1?	N/A	N/A	Ramp inside XWalk2?	N/A
	Road Slope (%)	3.3		Clear Space?	N/A
	Road X Slope (%)	0.4	N/A	Clear Space to XWalk (in)	N/A
N/A	Any Obstructions?	N/A	N/A	Storm Grate/Utility Hazard?	N/A
	Obstruction Type			Storm Grate/Utility Type	
		N/A			N/A
			Yes	Surface Condition? (G/P)	Good
			N/A	Curb Slope (%)	2.5

Remove & Replace Curb Ramp With Two New Directional Ramps or Equivalent.
