# Access Compliance Report

## Public Rights-of-Way

### (Curb Ramps)

| Intersection ID: 29716 | Main Street: GATESVILLE_LN | Cross Street: MEDOC_MOUNTAIN_DR | Location: W |

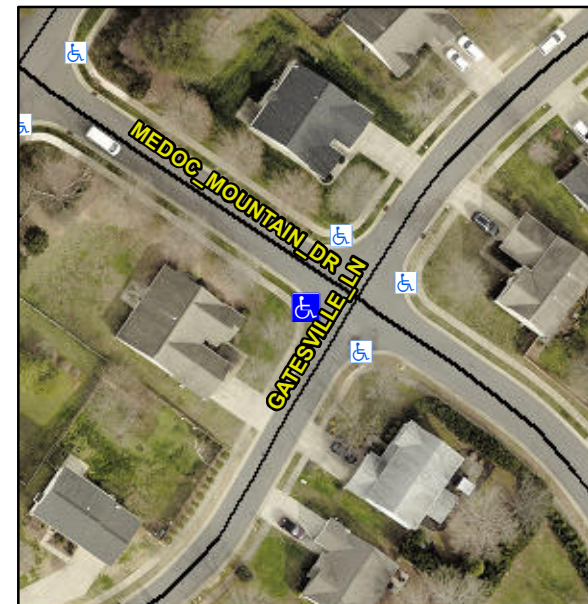
| ADA ID: 352CCCBE9E8F | Ramp Type: BlendTrans1 | Initial Pass/Fail: Pass | Overall Compliance: No |
| | | | Severity Score: 10.25 |

| Compliance | Description | Data | Compliance | Description | Data |
|---|---|---|---|---|---|
| Yes | Ramp Width (in) | 56.0 | No | BlendTrans XSlope (%) | 2.6 |
| Yes | Landing Length (in) | 48.0 | No | DWS Provided? | No |
| No | Landing Slope (%) | 2.1 | N/A | DWS Length (in) | N/A |

**Remove & Replace Curb Ramp With Two New Directional Ramps or Equivalent.**

**R304.5.3, R304.2.2-Perp, R304.3.2-Para, R305**

Total Cost: \$ 3200.00
