Access Compliance Report

Public Rights-of-Way

(Curb Ramps)

Intersection ID: 9651	Main Street: CRESTVIEW_DR	Cross Street: MATTOON_ST	Location: NE
ADA ID: 355190F2E7DE	Ramp Type: PerpDiag	Initial Pass/Fail: Fail	Overall Compliance: No
Codes/Mitigation Info/Possible Solution			Severity Score: 10
			Field Measurements/Component Compliance

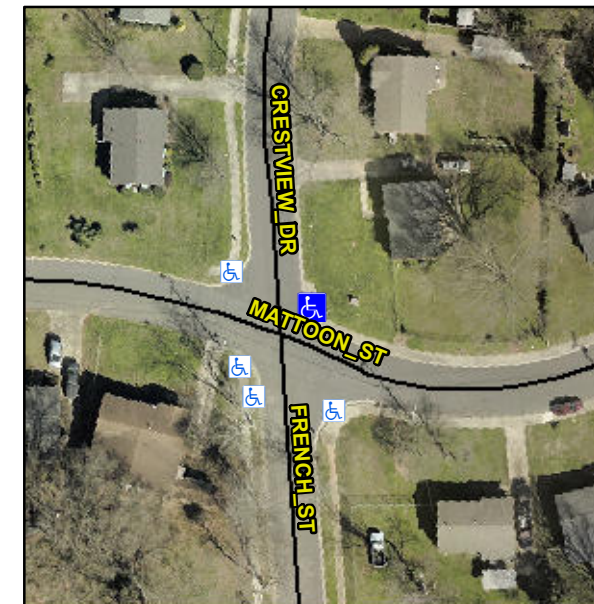
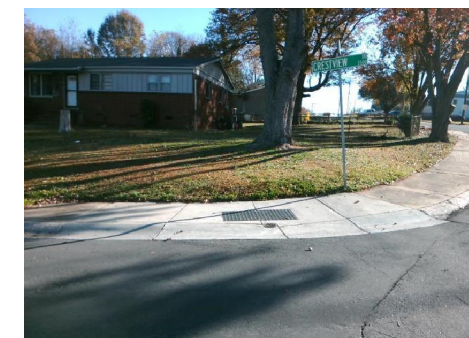
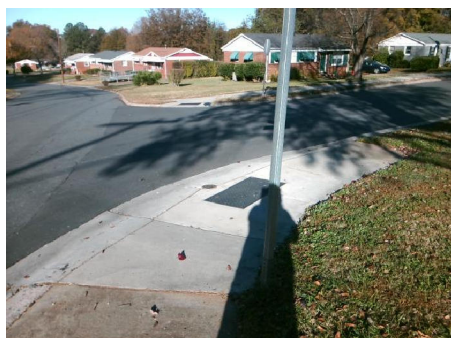
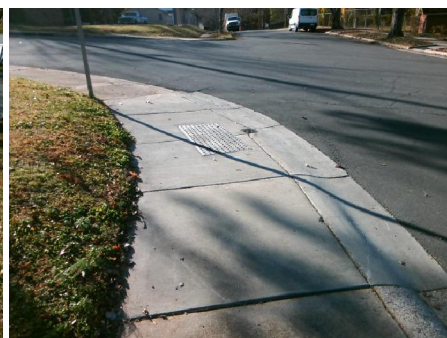
Not Found, R304.5.1, R304.5.3

Compliance	Description	Data	Compliance	Description	Data
N/A	Ramp Length (in)	61.5	Yes	Ramp Slope (%)	5.7
No	Ramp Width (in)	47.5	No	Ramp XSlope (%)	4.7
N/A	Flare Type LT	N/A	N/A	Flare Type RT	N/A
N/A	Flare Slope LT (%)	N/A	N/A	Flare Slope RT (%)	N/A
N/A	Flare Traversable LT?	N/A	N/A	Flare Traversable RT?	N/A
N/A	Landing Length (in)	N/A	N/A	DWS Provided?	N/A
N/A	Landing Width (in)	N/A	N/A	DWS Contrast?	N/A
N/A	Landing Slope (%)	N/A	N/A	DWS Length (in)	N/A
N/A	Landing X Slope (%)	N/A	N/A	DWS Full Width?	N/A
N/A	Landing Curb? (Y/N)	N/A	N/A	DWS Offset (in)	N/A
N/A	Shared Landing?	N/A			
N/A	Gutter Ponding?	N/A	N/A	Gutter Slope (%)	N/A
N/A	Gutter Lip Ht (in)	N/A	N/A	Gutter X Slope (%)	N/A
N/A	Painted X Walk1?	No	N/A	Painted X Walk2?	No
	X Walk 1 Direction	To W		X Walk 2 Direction	To S
N/A	X Walk 1 Width (in)	N/A	N/A	X Walk 2 Width (in)	N/A
	X Walk 1 Slope (%)	5.3		X Walk 2 Slope (%)	6.1
	X Walk 1 X Slope (%)	3.9		X Walk 2 X Slope (%)	3.6

N/A	Ramp inside XWalk1?	N/A	N/A	Ramp inside XWalk2?	N/A
	Road Slope (%)	5.5	N/A	Clear Space?	N/A
	Road X Slope (%)	1.7	N/A	Clear Space to XWalk (in)	N/A
N/A	Any Obstructions?	N/A	N/A	Storm Grate/Utility Hazard?	N/A
	Obstruction Type			Storm Grate/Utility Type	
		N/A			N/A
			Yes	Surface Condition? (G/P)	Good

Possible Solutions:

Remove & Replace Curb Ramp With Two New Directional Ramps or Equivalent.

Total Cost: \$ 3200.00
